Access Compliance Report Public Rights-of-Way (Curb Ramps)

Intersection ID: 3912 Main Street: DRIWOOD CT **Cross Street: PROSPERITY CHURCH RD** Location: ADA ID: 9A13CDD3BFE1 Ramp Type: PerpDiag Initial Pass/Fail: Fail **Overall Compliance: No** Severity Score: 33.75

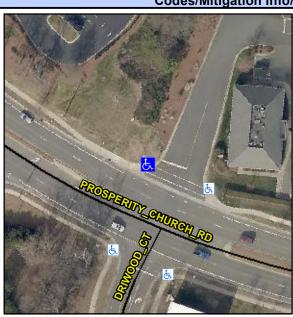
Compliance Description		Data	Comp	liance Description	Data
N/A	Ramp Length (in)	90.0	No	Ramp Slope (%)	15.6
No	Ramp Width (in)	44.5	Yes	Ramp XSlope (%)	1.7
N/A	Flare Type LT	N/A	N/A	Flare Type RT	N/A
N/A	Flare Slope LT (%)	N/A	N/A	Flare Slope RT (%)	N/A
N/A	Flare Traversable LT?	N/A	N/A	Flare Traversable RT?	N/A
N/A	Landing Length (in)	N/A	N/A	DWS Provided?	N/A
N/A	Landing Width (in)	N/A	N/A	DWS Contrast?	N/A
N/A	Landing Slope (%)	N/A	N/A	DWS Length (in)	N/A
N/A	Landing X Slope (%)	N/A	N/A	DWS Full Width?	N/A
N/A	Landing Curb? (Y/N)	N/A	N/A	DWS Offset (in)	N/A
N/A	Shared Landing?	N/A			
N/A	Gutter Ponding?	N/A	N/A	Gutter Slope (%)	N/A
N/A	Gutter Lip Ht (in)	N/A	N/A	Gutter X Slope (%)	N/A
N/A	Painted X Walk1?	No	N/A	Painted X Walk2?	Yes
	X Walk 1 Direction	To SW		X Walk 2 Direction	To SE
N/A	X Walk 1 Width (in)	N/A	N/A	X Walk 2 Width (in)	88.5
	X Walk 1 Slope (%)	0.8		X Walk 2 Slope (%)	2.0
	X Walk 1 X Slope (%)	1.2		X Walk 2 X Slope (%)	0.7

N/A	Ramp inside XWalk1?	N/A	N/A	Ramp inside XWalk2?	Yes
	Road Slope (%)	0.9	N/A	Clear Space?	N/A
	Road X Slope (%)	1.3	N/A	Clear Space to XWalk (in)	N/A
N/A	Any Obstructions?	N/A	N/A	Storm Grate/Utility Hazard?	N/A
	Obstruction Type			Storm Grate/Utility Type	
		N/A			N/A

PROSPERITY CHURC Street 1 Name Stop Condition-Street 2 Street 2 Name DRIWO Stop Condition-Street 1 Sto Remove & Replace Curb Ramp With **Two New Directional Ramps or** Equivalent.

3200.00
