Access Compliance Report

Public Rights-of-Way

(Curb Ramps)

Intersection ID: 17235	Main Street: LOMAX_AV	Cross Street: WRIGHT_AV	Location: SE
ADA ID: 9A1ABE65160E	Ramp Type: Perp	Initial Pass/Fail: Fail	Overall Compliance: No
		Severity Score: 25

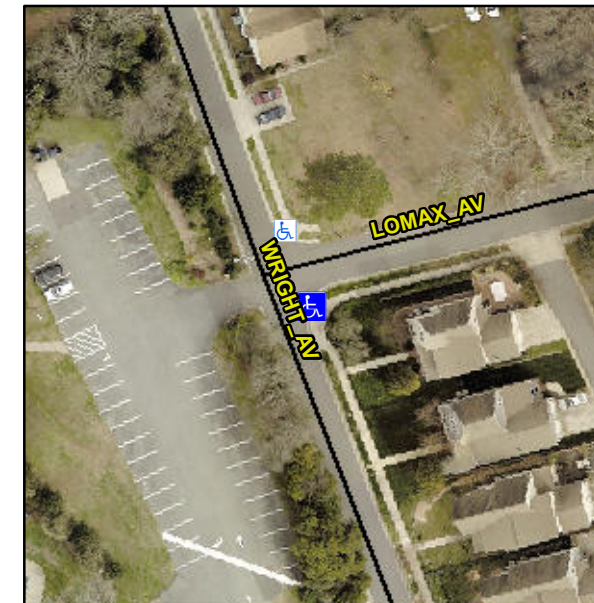
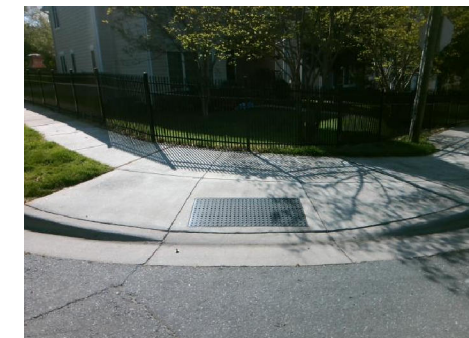
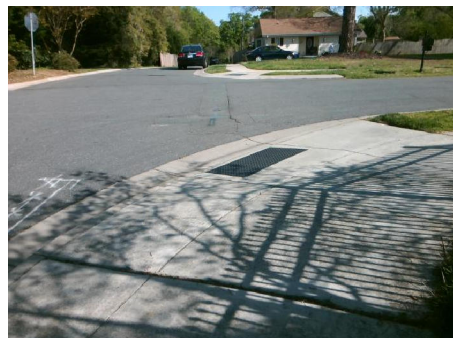
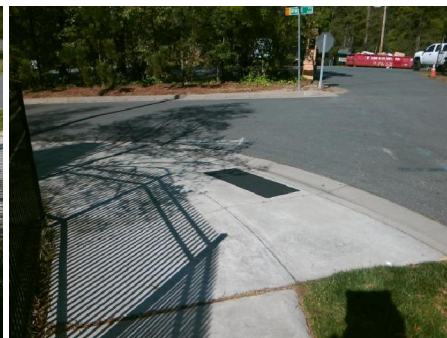
Not Found, R304.2.2, R304.5.3

Compliance	Description	Data	Compliance	Description	Data
N/A	Ramp Length (in)	50.5	No	Ramp Slope (%)	11.2
Yes	Ramp Width (in)	52.0	No	Ramp XSlope (%)	5.1
N/A	Flare Type LT	N/A	N/A	Flare Type RT	N/A
N/A	Flare Slope LT (%)	N/A	N/A	Flare Slope RT (%)	N/A
N/A	Flare Traversable LT?	N/A	N/A	Flare Traversable RT?	N/A
N/A	Landing Length (in)	N/A	N/A	DWS Provided?	N/A
N/A	Landing Width (in)	N/A	N/A	DWS Contrast?	N/A
N/A	Landing Slope (%)	N/A	N/A	DWS Length (in)	N/A
N/A	Landing X Slope (%)	N/A	N/A	DWS Full Width?	N/A
N/A	Landing Curb? (Y/N)	N/A	N/A	DWS Offset (in)	N/A
N/A	Shared Landing?	N/A			
N/A	Gutter Ponding?	N/A	N/A	Gutter Slope (%)	N/A
N/A	Gutter Lip Ht (in)	N/A	N/A	Gutter X Slope (%)	N/A
N/A	Painted X Walk1?	No	N/A	Painted X Walk2?	N/A
	X Walk 1 Direction	To N		X Walk 2 Direction	N/A
N/A	X Walk 1 Width (in)	N/A	N/A	X Walk 2 Width (in)	N/A
	X Walk 1 Slope (%)	4.2		X Walk 2 Slope (%)	N/A
	X Walk 1 X Slope (%)	3.4		X Walk 2 X Slope (%)	N/A

N/A	Ramp inside XWalk1?	N/A	N/A	Ramp inside XWalk2?	N/A
	Road Slope (%)	N/A	N/A	Clear Space?	N/A
	Road X Slope (%)	N/A	N/A	Clear Space to XWalk (in)	N/A
N/A	Any Obstructions?	N/A	N/A	Storm Grate/Utility Hazard?	N/A
	Obstruction Type			Storm Grate/Utility Type	
		N/A			N/A
			Yes	Surface Condition? (G/P)	Good

Remove & Replace Entire Ramp.

Total Cost: \$ 1850.00
