Access Compliance Report

Public Rights-of-Way

(Curb Ramps)

Intersection ID: 42772	Main Street: JEANETTE_CR	Cross Street: SWANSONG_LN	Location: E
ADA ID: 9A1B4A265392	Ramp Type: Perp	Initial Pass/Fail: Fail	Overall Compliance: No
Severity Score: 12.5			
Codes/Mitigation Info/Possible Solution		Field Measurements/Component Compliance

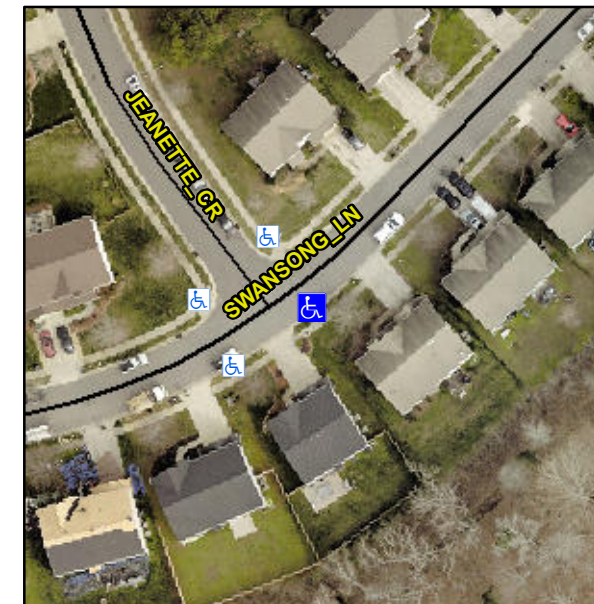
Not Found, R304.2.2

Compliance	Description	Data	Compliance	Description	Data
N/A	Ramp Length (in)	48.0	No	Ramp Slope (%)	8.5
Yes	Ramp Width (in)	50.5	Yes	Ramp XSlope (%)	1.1
N/A	Flare Type LT	N/A	N/A	Flare Type RT	N/A
N/A	Flare Slope LT (%)	N/A	N/A	Flare Slope RT (%)	N/A
N/A	Flare Traversable LT?	N/A	N/A	Flare Traversable RT?	N/A
N/A	Landing Length (in)	N/A	N/A	DWS Provided?	N/A
N/A	Landing Width (in)	N/A	N/A	DWS Contrast?	N/A
N/A	Landing Slope (%)	N/A	N/A	DWS Length (in)	N/A
N/A	Landing X Slope (%)	N/A	N/A	DWS Full Width?	N/A
N/A	Landing Curb? (Y/N)	N/A	N/A	DWS Offset (in)	N/A
N/A	Shared Landing?	N/A			
N/A	Gutter Ponding?	N/A	N/A	Gutter Slope (%)	N/A
N/A	Gutter Lip Ht (in)	N/A	N/A	Gutter X Slope (%)	N/A
N/A	Painted X Walk1?	No	N/A	Painted X Walk2?	N/A
	X Walk 1 Direction	To NW		X Walk 2 Direction	N/A
N/A	X Walk 1 Width (in)	N/A	N/A	X Walk 2 Width (in)	N/A
	X Walk 1 Slope (%)	6.7		X Walk 2 Slope (%)	N/A
	X Walk 1 X Slope (%)	1.5		X Walk 2 X Slope (%)	N/A

N/A	Ramp inside XWalk1?	N/A	N/A	Ramp inside XWalk2?	N/A
	Road Slope (%)	N/A	N/A	Clear Space?	N/A
	Road X Slope (%)	N/A	N/A	Clear Space to XWalk (in)	N/A
N/A	Any Obstructions?	N/A	N/A	Storm Grate/Utility Hazard?	N/A
	Obstruction Type			Storm Grate/Utility Type	
		N/A			N/A
			Yes	Surface Condition? (G/P)	Good

Possible Solutions:

Remove & Replace Entire Ramp.
