Access Compliance Report

Public Rights-of-Way

(Curb Ramps)

Intersection ID: 9891	Main Street: RAPHAEL_PL	Cross Street: CARD_ST	Location: SW
ADA ID: 9A240A050918	Ramp Type: Combination2	Initial Pass/Fail: Fail	Overall Compliance: No
		Severity Score: 22.5

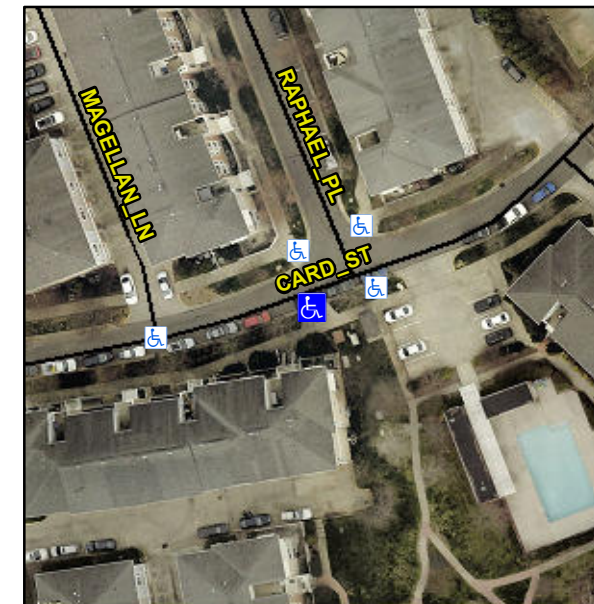
Not Found, R304.5.1, R304.2.2, R304.5.3

Compliance	Description	Data	Compliance	Description	Data
N/A	Ramp Length LT (in)	102.5	N/A	Ramp Length RT (in)	N/A
Yes	Ramp Width LT (in)	72.0	N/A	Ramp Width RT (in)	N/A
Yes	Ramp Slope LT (%)	5.0	N/A	Ramp Slope RT (%)	N/A
No	Ramp XSlope LT (%)	2.7	N/A	Ramp XSlope RT (%)	N/A
N/A	Ramp Length (in)	95.0	No	Ramp Slope (%)	9.3
No	Ramp Width (in)	47.5	Yes	Ramp XSlope (%)	1.5
N/A	Flare Type LT	N/A	N/A	Flare Type RT	N/A
N/A	Flare Slope LT (%)	N/A	N/A	Flare Slope RT (%)	N/A
N/A	Flare Traversable LT?	N/A	N/A	Flare Traversable RT?	N/A
N/A	Landing Length (in)	N/A	N/A	DWS Provided?	N/A
N/A	Landing Width (in)	N/A	N/A	DWS Contrast?	N/A
N/A	Landing Slope (%)	N/A	N/A	DWS Length (in)	N/A
N/A	Landing X Slope (%)	N/A	N/A	DWS Full Width?	N/A
N/A	Landing Curb? (Y/N)	N/A	N/A	DWS Offset (in)	N/A
N/A	Shared Landing?	N/A			
N/A	Gutter Ponding?	N/A	N/A	Gutter Slope (%)	N/A
N/A	Gutter Lip Ht (in)	N/A	N/A	Gutter X Slope (%)	N/A
N/A	Painted X Walk1?	No	N/A	Painted X Walk2?	N/A

X Walk 1 Direction	To N		X Walk 2 Direction	N/A
	X Walk 1 Width (in)	N/A		X Walk 2 Width (in)	N/A
	X Walk 1 Slope (%)	0.4		X Walk 2 Slope (%)	N/A
	X Walk 1 X Slope (%)	1.3		X Walk 2 X Slope (%)	N/A
N/A	Ramp inside XWalk1?	N/A	N/A	Ramp inside XWalk2?	N/A
	Road Slope (%)	N/A		Clear Space?	N/A
	Road X Slope (%)	N/A	N/A	Clear Space to XWalk (in)	N/A
			N/A	Any Obstruction?	N/A
				Obstruction Type	N/A
			N/A	Storm Grate/Utility Hazard?	N/A
				Storm Grate/Utility Type	N/A
Yes	Surface Condition? (G/P)	Good			
	Curb Slope (%)	7.3

Remove & Replace Entire Ramp.
