Access Compliance Report

Public Rights-of-Way

(Curb Ramps)

Intersection ID: N/A	Main Street: COSTIGAN_LN	Cross Street: DURANT_BV	Location: W
ADA ID: 9A2446285AC5	Ramp Type: PerpDiag	Initial Pass/Fail: Fail	Overall Compliance: No
		Severity Score: 22.5

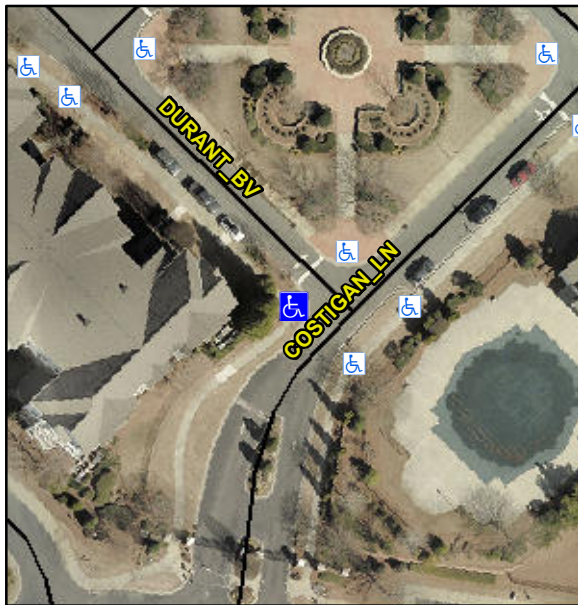
Not Found, R304.5.1, R304.2.2, R304.5.3

Compliance	Description	Data	Compliance	Description	Data
N/A	Ramp Length (in)	103.0	No	Ramp Slope (%)	9.2
No	Ramp Width (in)	47.0	No	Ramp XSlope (%)	5.0
N/A	Flare Type LT	N/A	N/A	Flare Type RT	N/A
N/A	Flare Slope LT (%)	N/A	N/A	Flare Slope RT (%)	N/A
N/A	Flare Traversable LT?	N/A	N/A	Flare Traversable RT?	N/A
N/A	Landing Length (in)	N/A	N/A	DWS Provided?	N/A
N/A	Landing Width (in)	N/A	N/A	DWS Contrast?	N/A
N/A	Landing Slope (%)	N/A	N/A	DWS Length (in)	N/A
N/A	Landing X Slope (%)	N/A	N/A	DWS Full Width?	N/A
N/A	Landing Curb? (Y/N)	N/A	N/A	DWS Offset (in)	N/A
N/A	Shared Landing?	N/A			
N/A	Gutter Ponding?	N/A	N/A	Gutter Slope (%)	N/A
N/A	Gutter Lip Ht (in)	N/A	N/A	Gutter X Slope (%)	N/A
N/A	Painted X Walk1?	No	N/A	Painted X Walk2?	No
	X Walk 1 Direction	To SE		X Walk 2 Direction	To NE
N/A	X Walk 1 Width (in)	N/A	N/A	X Walk 2 Width (in)	N/A
	X Walk 1 Slope (%)	0.8		X Walk 2 Slope (%)	5.1
	X Walk 1 X Slope (%)	4.2		X Walk 2 X Slope (%)	1.9

N/A	Ramp inside XWalk1?	N/A	N/A	Ramp inside XWalk2?	N/A
	Road Slope (%)	3.8	N/A	Clear Space?	N/A
	Road X Slope (%)	0.2	N/A	Clear Space to XWalk (in)	N/A
N/A	Any Obstructions?	N/A	N/A	Storm Grate/Utility Hazard?	N/A
	Obstruction Type			Storm Grate/Utility Type	
		N/A			N/A
			Yes	Surface Condition? (G/P)	Good

Remove & Replace Curb Ramp With Two New Directional Ramps or Equivalent.
