# Access Compliance Report

## Public Rights-of-Way

### (Curb Ramps)

| Intersection ID: 44490 | Main Street: CHALKSTONE_RD | Cross Street: DARWICK_ST | Location: NW |

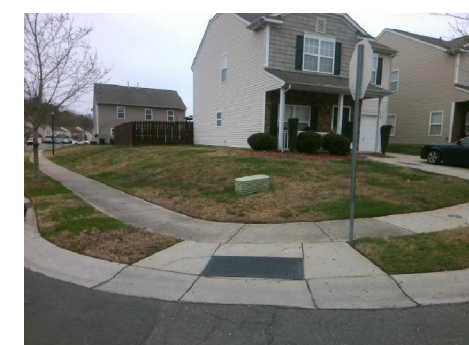
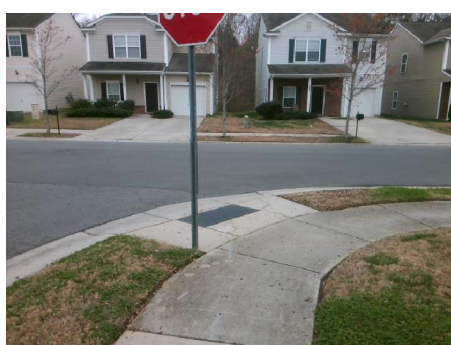
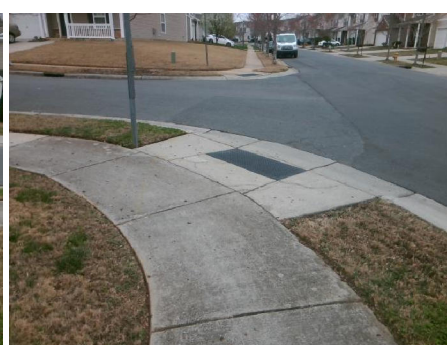
| ADA ID: 9A25D81F221F | Ramp Type: PerpDiag | Initial Pass/Fail: Fail | Overall Compliance: No |

**Not Found, R304.5.1, R304.5.3**

| Compliance | Description | Data | Compliance | Description | Data |
|---|---|---|---|---|---|
| N/A | Ramp Length (in) | 47.0 | Yes | Ramp Slope (%) | 5.8 |
| No | Ramp Width (in) | 47.0 | No | Ramp XSlope (%) | 3.4 |

**Remove & Replace Curb Ramp With Two New Directional Ramps or Equivalent.**
