# Access Compliance Report

## Public Rights-of-Way

| Intersection ID: 20865 | Main Street: SIMSBURY_RD | Cross Street: VALENCIA_TR | Location: SE |
| ADA ID: 9A279627690E | Ramp Type: PerpDiag | Initial Pass/Fail: Fail | Overall Compliance: No |

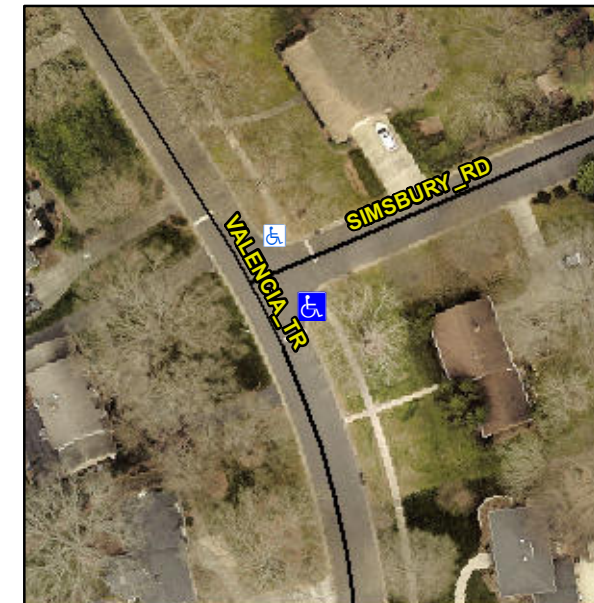
**R304.5.1, R304.2.2, R304.5.3**

| Compliance | Description | Data | Compliance | Description | Data |
|---|---|---|---|---|---|
| N/A | Ramp Length (in) | 43.0 | No | Ramp Slope (%) | 8.6 |
| No | Ramp Width (in) | 30.0 | No | Ramp XSlope (%) | 7.6 |

**Remove & Replace Curb Ramp With Two New Directional Ramps or Equivalent.**
