# Access Compliance Report

## Public Rights-of-Way

### (Curb Ramps)

| Intersection ID: 30060 | Main Street: DILLARD RIDGE DR | Cross Street: WATERS TRAIL DR | Location: | N |

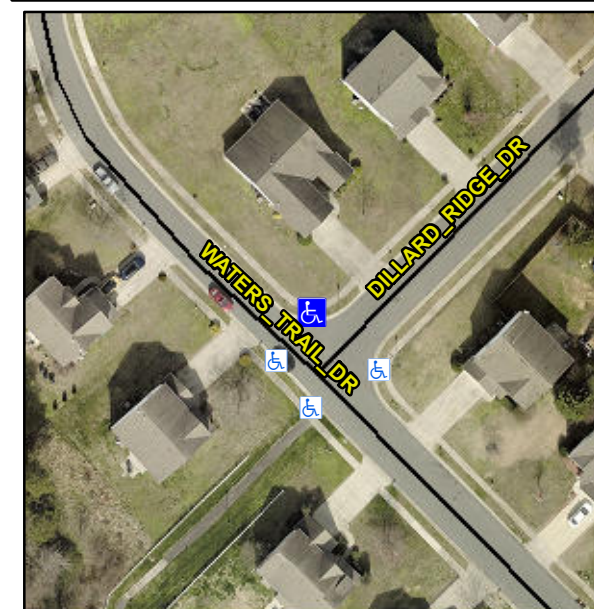
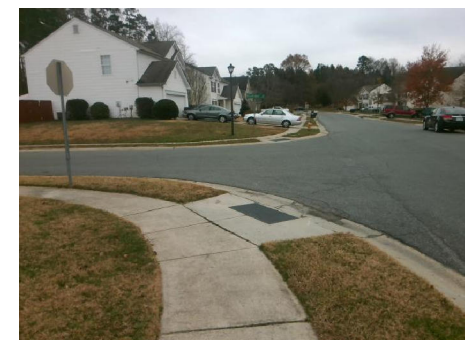
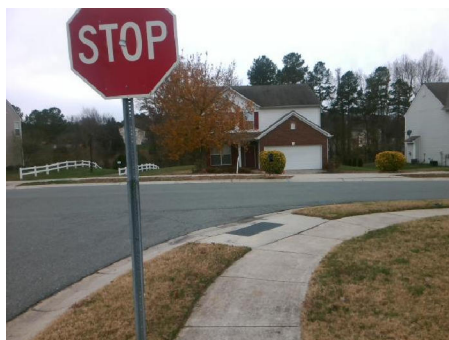
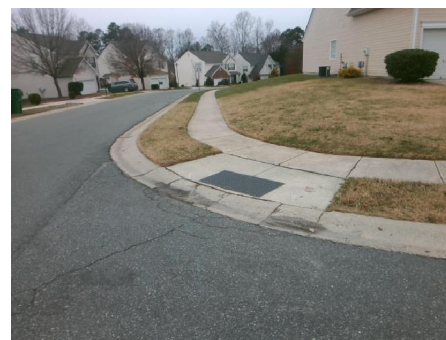
| ADA ID: 9A3F938CAE77 | Ramp Type: BlendTrans2 | Initial Pass/Fail: Pass | Overall Compliance: No | Severity Score: 0 |

**CURB GAP 1.0, RAMP LIP 1.0, CURB WIDTH 31.0**

**Not Found, R305.2**

| Compliance | Description | Data | Compliance | Description | Data |
|---|---|---|---|---|---|
| N/A | Landing Curb? (Y/N) | No | No | DWS Offset (in) | 3.0 |
| | | | No | Curb Slope (%) | 22.1 |

**Remove & Replace Curb Ramp With Two New Directional Ramps or Equivalent.**

Total Cost: \$ 3200.00
