# Access Compliance Report

## Public Rights-of-Way (Curb Ramps)

Intersection ID: 10041795	Main Street: WILLIAMS_POND_LN	Cross Street: N/A	Location:	N
ADA ID: 9A4AC602DDEF	Ramp Type: BlendTrans1	Initial Pass/Fail: Fail	Overall Compliance: No	Severity Score: 1.25
Codes/Mitigation Info/Possible Solution		Field Measurements/Component Compliance

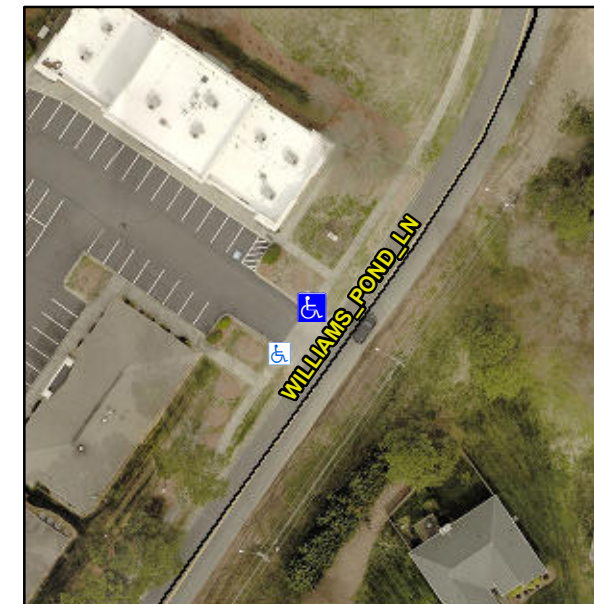
Compliance	Description	Data	Compliance	Description	Data
N/A	Ramp Length (in)	86.0	Yes	BlendTrans Slope (%)	0.8
Yes	Ramp Width (in)	59.0	No	BlendTrans XSlope (%)	3.0
N/A	Flare Type LT	N/A	N/A	Flare Type RT	N/A
N/A	Flare Slope LT (%)	N/A	N/A	Flare Slope RT (%)	N/A
N/A	Flare Traversable LT?	N/A	N/A	Flare Traversable RT?	N/A
N/A	Landing Length (in)	N/A	N/A	DWS Provided?	N/A
N/A	Landing Width (in)	N/A	N/A	DWS Contrast?	N/A
N/A	Landing Slope (%)	N/A	N/A	DWS Length (in)	N/A
N/A	Landing X Slope (%)	N/A	N/A	DWS Full Width?	N/A
N/A	Landing Curb? (Y/N)	N/A	N/A	DWS Offset (in)	N/A
N/A	Shared Landing?	N/A			
N/A	Gutter Ponding?	N/A	N/A	Gutter Slope (%)	N/A
N/A	Gutter Lip Ht (in)	N/A	N/A	Gutter X Slope (%)	N/A
N/A	Painted X Walk1?	No	N/A	Painted X Walk2?	N/A
	X Walk 1 Direction	To SW		X Walk 2 Direction	N/A
	X Walk 1 Width (in)	N/A		X Walk 2 Width (in)	N/A
	X Walk 1 Slope (%)	0.4		X Walk 2 Slope (%)	N/A
	X Walk 1 X Slope (%)	2.4		X Walk 2 X Slope (%)	N/A

N/A	Ramp inside XWalk1?	N/A	N/A	Ramp inside XWalk2?	N/A
	Road Slope (%)	2.4		Clear Space?	N/A
	Road X Slope (%)	0.4	N/A	Clear Space to XWalk (in)	N/A
N/A	Any Obstructions?	N/A	N/A	Storm Grate/Utility Hazard?	N/A
	Obstruction Type			Storm Grate/Utility Type	
		N/A			N/A
			Yes	Surface Condition? (G/P)	Good
			No	Curb Slope (%)	8.5

**Remove & Replace Curb Ramp With Two New Directional Ramps or Equivalent.**

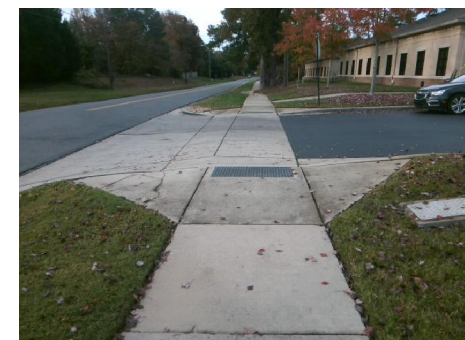
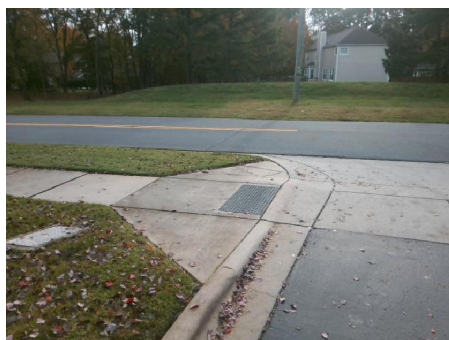
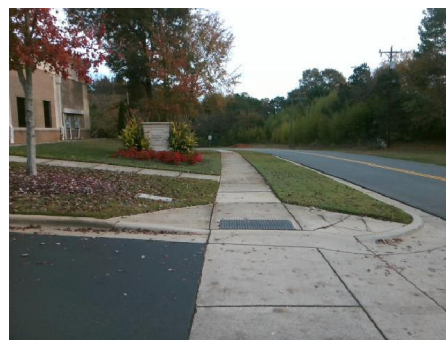
Street 1 Name	ENTRANCE
Stop Condition-Street 1	StopSign
Street 2 Name	N/A
Stop Condition-Street 2	N/A
