Access Compliance Report

Public Rights-of-Way

(Curb Ramps)

Intersection ID: 24455	Main Street: S_TRYON_ST	Cross Street: STEELE_CREEK_RD	Location: SE
ADA ID: 9A55C73315C1	Ramp Type: Perp	Initial Pass/Fail: Fail	Overall Compliance: No
			Severity Score: 21.25

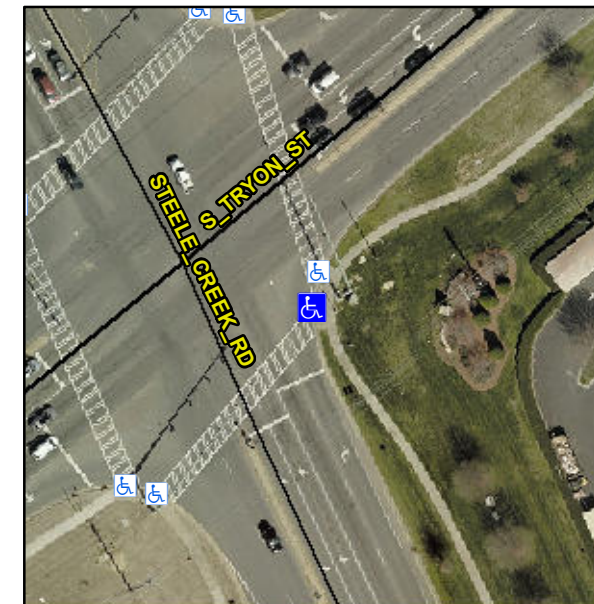
Compliance	Description	Data	Compliance	Description	Data
N/A	Ramp Length (in)	48.0	No	Ramp Slope (%)	8.9
No	Ramp Width (in)	46.0	Yes	Ramp XSlope (%)	1.3
N/A	Flare Type LT	N/A	N/A	Flare Type RT	N/A
N/A	Flare Slope LT (%)	N/A	N/A	Flare Slope RT (%)	N/A
N/A	Flare Traversable LT?	N/A	N/A	Flare Traversable RT?	N/A
N/A	Landing Length (in)	N/A	N/A	DWS Provided?	N/A
N/A	Landing Width (in)	N/A	N/A	DWS Contrast?	N/A
N/A	Landing Slope (%)	N/A	N/A	DWS Length (in)	N/A
N/A	Landing X Slope (%)	N/A	N/A	DWS Full Width?	N/A
N/A	Landing Curb? (Y/N)	N/A	N/A	DWS Offset (in)	N/A
N/A	Shared Landing?	N/A			
N/A	Gutter Ponding?	N/A	N/A	Gutter Slope (%)	N/A
N/A	Gutter Lip Ht (in)	N/A	N/A	Gutter X Slope (%)	N/A
N/A	Painted X Walk1?	Yes	N/A	Painted X Walk2?	N/A
	X Walk 1 Direction	To SW		X Walk 2 Direction	N/A
N/A	X Walk 1 Width (in)	120.0	N/A	X Walk 2 Width (in)	N/A
	X Walk 1 Slope (%)	2.7		X Walk 2 Slope (%)	N/A
	X Walk 1 X Slope (%)	1.4		X Walk 2 X Slope (%)	N/A

N/A	Ramp inside XWalk1?	Yes	N/A	Ramp inside XWalk2?	N/A
	Road Slope (%)	N/A	N/A	Clear Space?	N/A
	Road X Slope (%)	N/A	N/A	Clear Space to XWalk (in)	N/A
N/A	Any Obstructions?	N/A	N/A	Storm Grate/Utility Hazard?	N/A
	Obstruction Type			Storm Grate/Utility Type	
		N/A			N/A
			Yes	Surface Condition? (G/P)	Good

Remove & Replace Entire Ramp.

R304.5.1, R304.2.2
