# Access Compliance Report

## Public Rights-of-Way

### (Curb Ramps)

| Intersection ID: 28845 | Main Street: FAIRGLEN_RD | Cross Street: FAIRSTONE_AV | Location: NE |

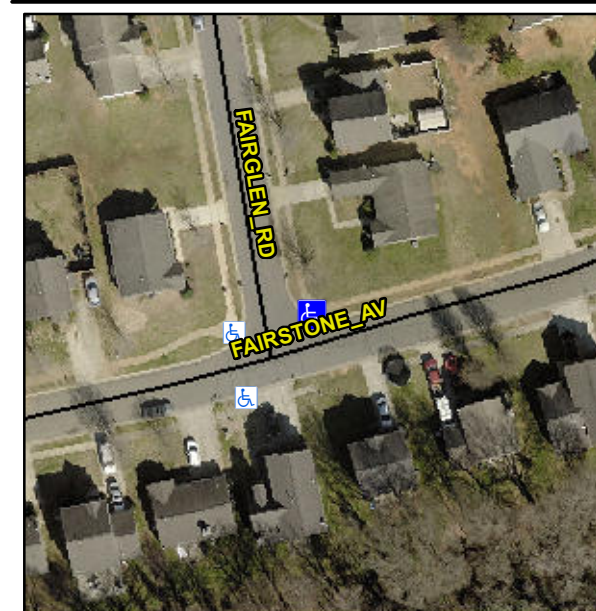
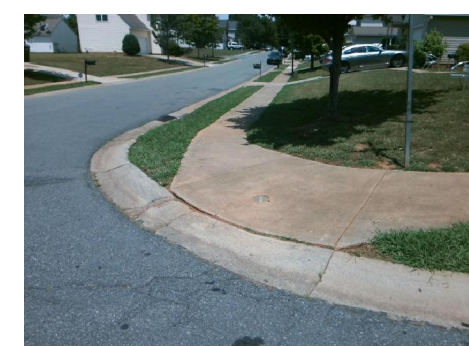
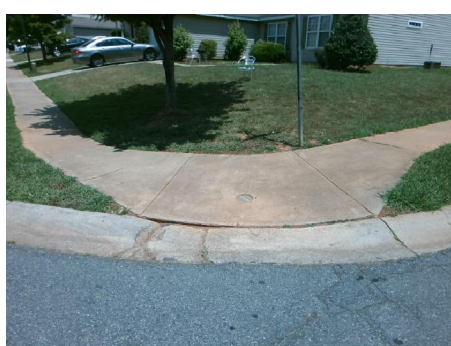
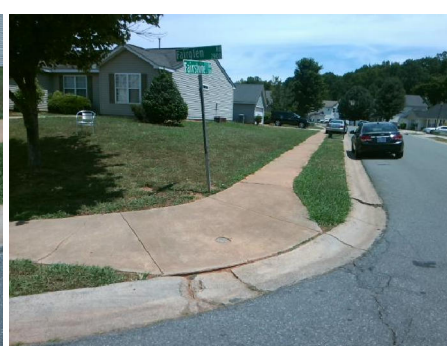
**Not Found, R304.5.3, R302.7**

| Compliance | Description | Data | Compliance | Description | Data |
|---|---|---|---|---|---|
| Yes | Ramp Width (in) | 66.0 | No | Ramp XSlope (%) | 9.1 |
| | | No | | Surface Condition? (G/P) | Poor |

**Remove & Replace Entire Ramp.**
