Access Compliance Report

Public Rights-of-Way

(Curb Ramps)

Intersection ID: 50598	Main Street: BENDING_BRANCH_RD	Cross Street: BEAR_GRASS_LN	Location: NW
ADA ID: 9A597925F587	Ramp Type: Perp	Initial Pass/Fail: Fail	Overall Compliance: No
		Severity Score: 12.5

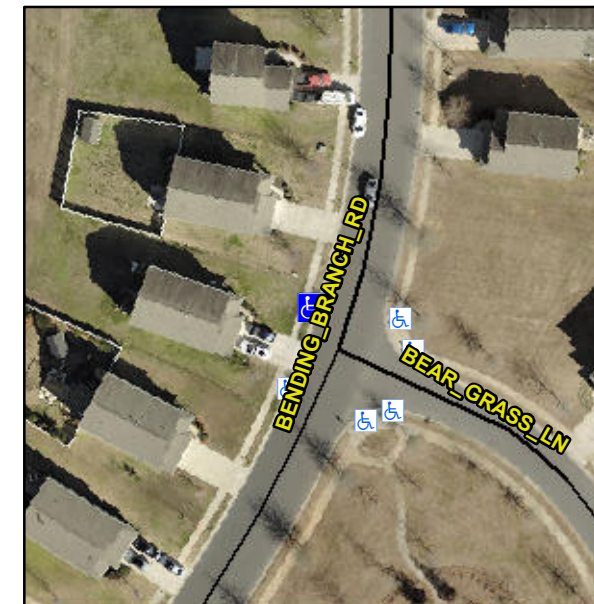
Not Found, R304.2.2

Compliance	Description	Data	Compliance	Description	Data
N/A	Ramp Length (in)	48.0	No	Ramp Slope (%)	8.7
Yes	Ramp Width (in)	48.0	Yes	Ramp XSlope (%)	0.1
N/A	Flare Type LT	N/A	N/A	Flare Type RT	N/A
N/A	Flare Slope LT (%)	N/A	N/A	Flare Slope RT (%)	N/A
N/A	Flare Traversable LT?	N/A	N/A	Flare Traversable RT?	N/A
N/A	Landing Length (in)	N/A	N/A	DWS Provided?	N/A
N/A	Landing Width (in)	N/A	N/A	DWS Contrast?	N/A
N/A	Landing Slope (%)	N/A	N/A	DWS Length (in)	N/A
N/A	Landing X Slope (%)	N/A	N/A	DWS Full Width?	N/A
N/A	Landing Curb? (Y/N)	N/A	N/A	DWS Offset (in)	N/A
N/A	Shared Landing?	N/A			
N/A	Gutter Ponding?	N/A	N/A	Gutter Slope (%)	N/A
N/A	Gutter Lip Ht (in)	N/A	N/A	Gutter X Slope (%)	N/A
N/A	Painted X Walk1?	No	N/A	Painted X Walk2?	N/A
	X Walk 1 Direction	To E		X Walk 2 Direction	N/A
N/A	X Walk 1 Width (in)	N/A	N/A	X Walk 2 Width (in)	N/A
	X Walk 1 Slope (%)	4.2		X Walk 2 Slope (%)	N/A
	X Walk 1 X Slope (%)	1.1		X Walk 2 X Slope (%)	N/A

Remove & Replace Entire Ramp.
