# Access Compliance Report

## Public Rights-of-Way

### (Curb Ramps)

| Intersection ID: 32085 | Main Street: JERPOINT_ABBY_DR | Cross Street: LISMORE_CASTLE_CT | Location: NE |

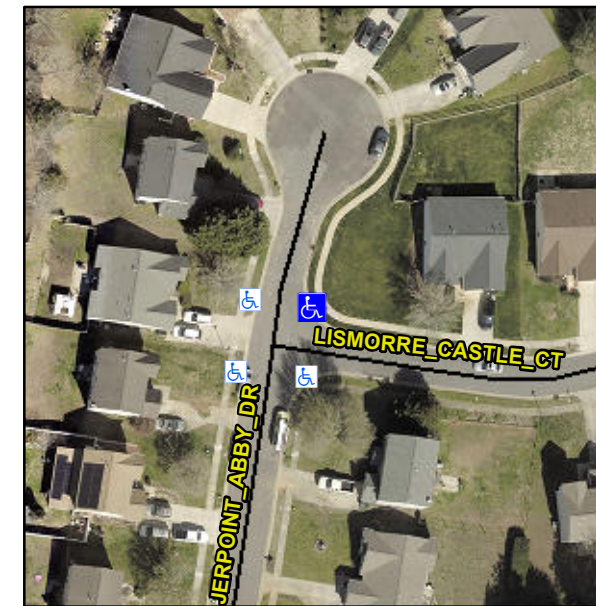
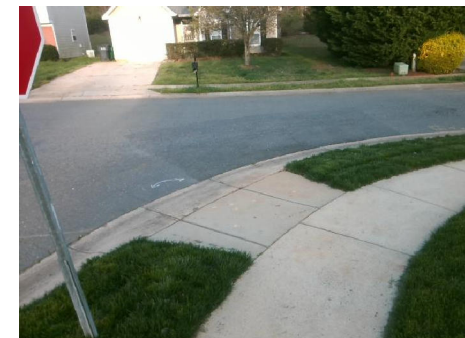
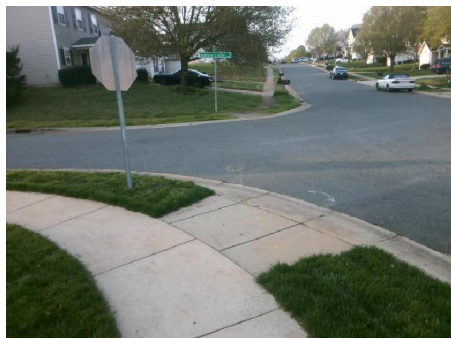
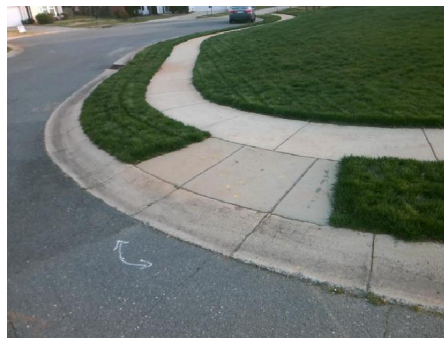
| ADA ID: 9A645D9CBEF6 | Ramp Type: BlendTrans1 | Initial Pass/Fail: Fail | Overall Compliance: No |
| Severity Score: 10 | | | |

**R304.5.1, R304.5.3**

| Compliance | Description | Data | Compliance | Description | Data |
|---|---|---|---|---|---|
| N/A | Ramp Length (in) | 47.5 | Yes | BlendTrans Slope (%) | 4.5 |
| No | Ramp Width (in) | 39.0 | No | BlendTrans XSlope (%) | 2.1 |

**Remove & Replace Curb Ramp With Two New Directional Ramps or Equivalent.**

Total Cost: \$ 3200.00
