| Intersection ID: 49396 | Main Street: BARROSO_LN | Cross Street: ROMANA_RED_LN | Location: | NE |
| ADA ID: 9A6930889747 | Ramp Type: BlendTrans1 | Initial Pass/Fail: Pass | Overall Compliance: No | Severity Score: 12.75 |

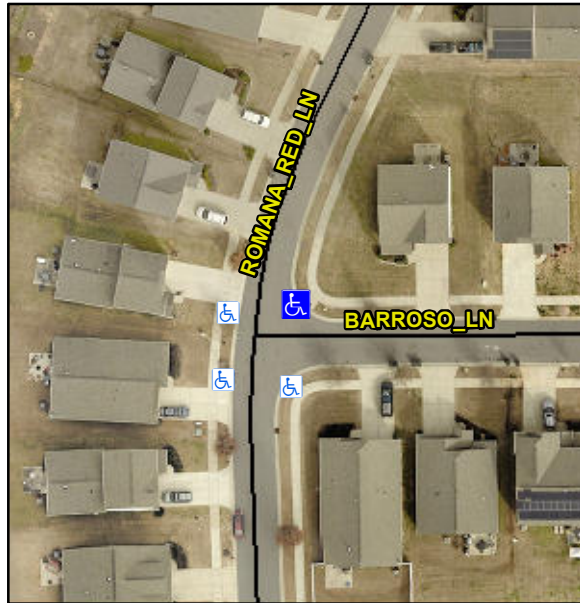
**Not Found, R304.5.3, R305.2,  
R302.7.2, R304.5.4**

| Compliance | Description | Data | Compliance | Description | Data |
|---|---|---|---|---|---|
| No | Landing X Slope (%) | 3.7 | Yes | DWS Full Width? | Yes |
| Yes | Gutter Ponding? | No | No | Gutter Slope (%) | 11.6 |
| No | Gutter Lip Ht (in) | 0.5 | Yes | Gutter X Slope (%) | 1.5 |

**Remove & Replace Curb Ramp With Two New Directional Ramps or Equivalent. Remove & Replace Gutter.**

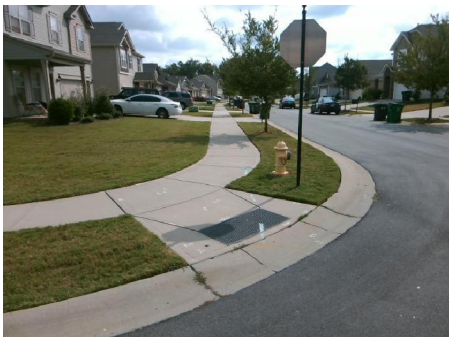
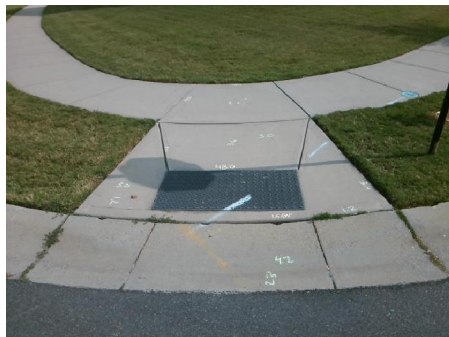
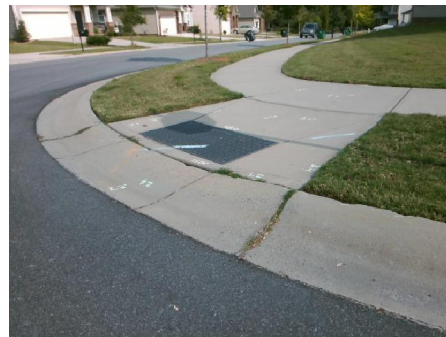
| Compliance | Description | Data | Compliance | Description | Data |
|---|---|---|---|---|---|
| Yes | Ramp Width (in) | 48.0 | No | BlendTrans XSlope (%) | 3.0 |
| N/A | Landing Curb? (Y/N) | No | No | DWS Offset (in) | 5.0 |
| | | | No | Curb Slope (%) | 13.0 |
