# Access Compliance Report

## Public Rights-of-Way

### (Curb Ramps)

| Intersection ID: 47087 | Main Street: MARVIN_RD | Cross Street: COVENTRY_COURT_LN | Location: SW |

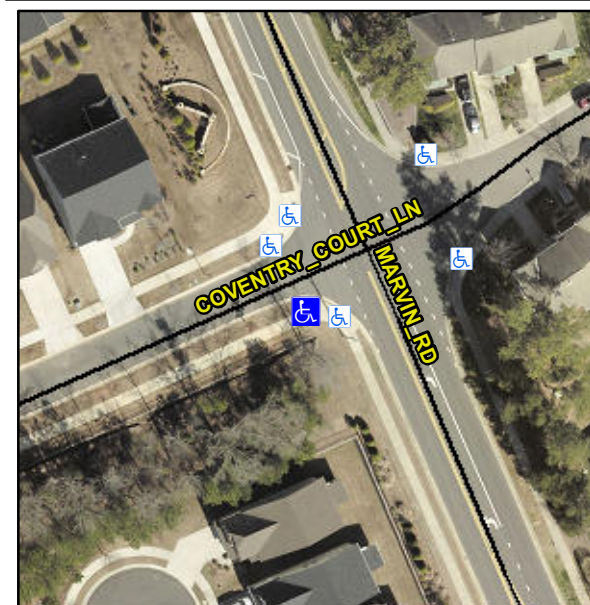
| ADA ID: 9A749B82B9AB | Ramp Type: BlendTrans1 | Initial Pass/Fail: Fail | Overall Compliance: No |
| Severity Score: 1.25 | | | |

**Not Found, R304.5.3**

| Compliance | Description | Data | Compliance | Description | Data |
|---|---|---|---|---|---|
| Yes | Ramp Width (in) | 61.0 | No | BlendTrans XSlope (%) | 3.1 |

**Remove & Replace Curb Ramp With Two New Directional Ramps or Equivalent.**

Total Cost: \$ 3200.00

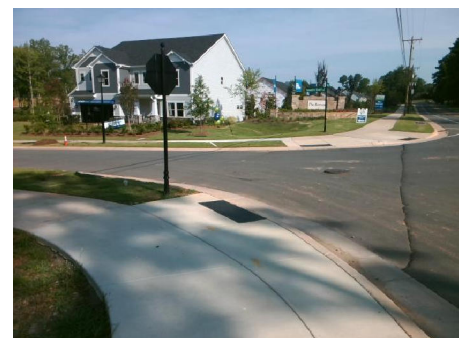
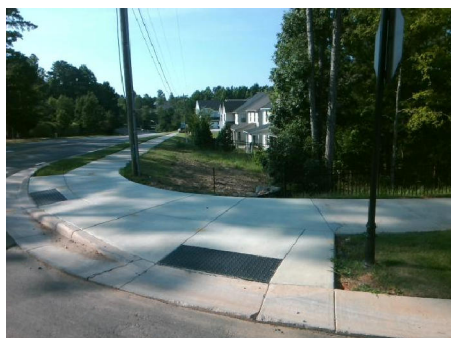
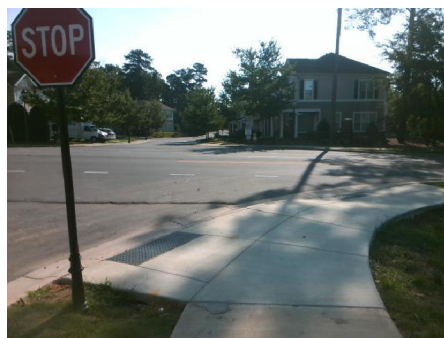
| Compliance | Description | Data | Compliance | Description | Data |
|---|---|---|---|---|---|
| N/A | Ramp Length (in) | 65.0 | Yes | BlendTrans Slope (%) | 4.0 |
| | | | No | Curb Slope (%) | 6.0 |
