Access Compliance Report Public Rights-of-Way (Curb Ramps)

Intersection ID: 9223Main Street: HILO_DRCross Street: N_TRYON_STLocation: NWADA ID: 9A7E57C53A9FRamp Type: ParaInitial Pass/Fail: Fail Overall Compliance: No Severity Score: 12.5

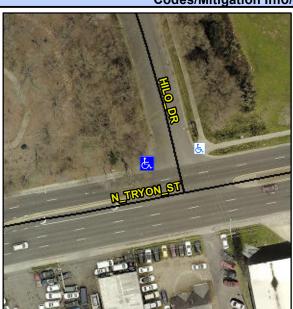
RT RP < 5%

R304.5.3

Field Measurements/Cor Compliance Description Data C				Compliance Description Data		
N/A	Ramp Length LT (in)	37.5	N/A	Ramp Length RT (in)	63.0	
Yes	Ramp Width LT (in)	60.0	Yes	Ramp Width RT (in)	69.0	
Yes	Ramp Slope LT (%)	7.0	Yes	Ramp Slope RT (%)	1.3	
No	Ramp XSlope LT (%)	6.1	Yes	Ramp XSlope RT (%)	1.0	
N/A	Landing Length (in)	N/A	N/A	DWS Provided?	N/A	
N/A	Landing Width (in)	N/A	N/A	DWS Contrast?	N/A	
N/A	Landing Slope (%)	N/A	N/A	DWS Length (in)	N/A	
N/A	Landing X Slope (%)	N/A	N/A	DWS Full Width?	N/A	
N/A	Landing Curb? (Y/N)	N/A	N/A	DWS Offset (in)	N/A	
N/A	Shared Landing?	N/A				
N/A	Gutter Ponding?	N/A	N/A	Gutter Slope (%)	N/A	
N/A	Gutter Lip Ht (in)	N/A	N/A	Gutter X Slope (%)	N/A	
N/A	Painted X Walk1?	No	N/A	Painted X Walk2?	N/A	
	X Walk 1 Direction	To E		X Walk 2 Direction	N/A	
N/A	X Walk 1 Width (in)	N/A	N/A	X Walk 2 Width (in)	N/A	
	X Walk 1 Slope (%)	0.5		X Walk 2 Slope (%)	N/A	
	X Walk 1 X Slope (%)	0.9		X Walk 2 X Slope (%)	N/A

N/A	Ramp inside XWalk1?	N/A	N/A	Ramp inside XWalk2?	N/A	
	Road Slope (%)	N/A	N/A	Clear Space?	N/A	
	Road X Slope (%)	N/A	N/A	Clear Space to XWalk (in)	N/A	
N/A	Any Obstructions?	N/A	N/A	Storm Grate/Utility Hazard?	N/A	
	Obstruction Type			Storm Grate/Utility Type		
		N/A			N/A	
			Yes	Surface Condition? (G/P)	Good	
			N/A	Curb Slope (%)	15.6

Remove & Replace Entire Ramp.
