Access Compliance Report

Public Rights-of-Way

(Curb Ramps)

Intersection ID: N/A	Main Street: CHOYCE_RD	Cross Street: CHOYCE_RD	Location: S
ADA ID: 9A8A557D4048	Ramp Type: Perp	Initial Pass/Fail: Pass	Overall Compliance: No
Severity Score: 15			
Codes/Mitigation Info/Possible Solution		Field Measurements/Component Compliance

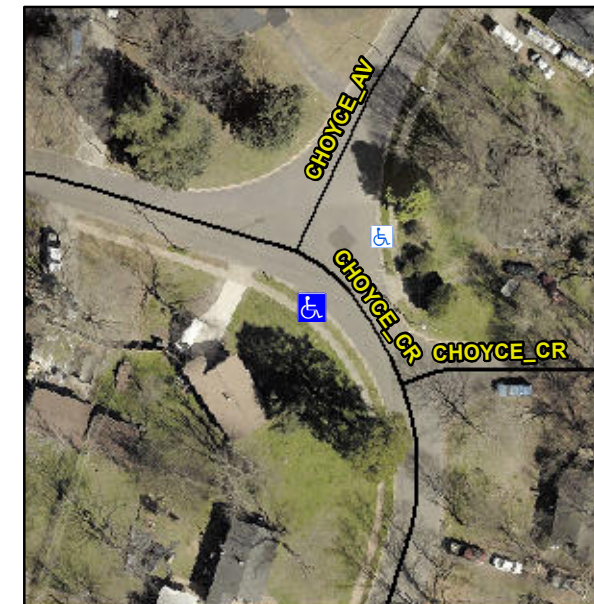
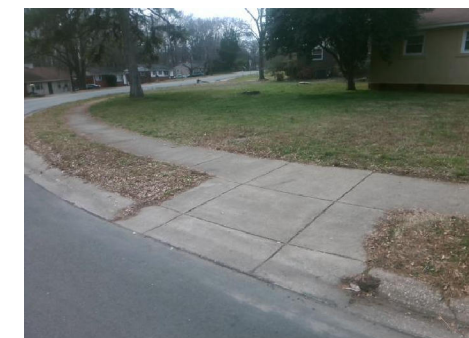
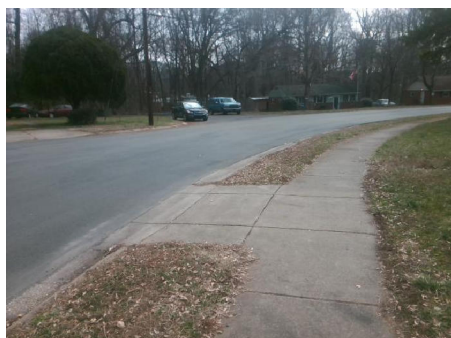
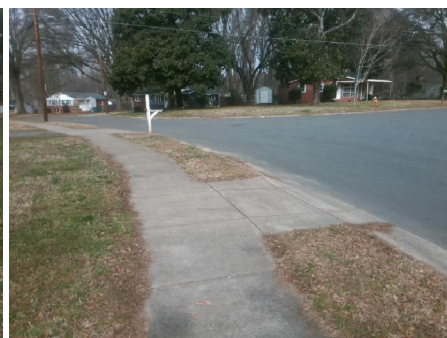
Compliance	Description	Data	Compliance	Description	Data
N/A	Ramp Length (in)	48.0	Yes	Ramp Slope (%)	6.2
Yes	Ramp Width (in)	60.0	Yes	Ramp XSlope (%)	1.7
N/A	Flare Type LT	Sloped	N/A	Flare Type RT	N/A
N/A	Flare Slope LT (%)	0.4	Yes	Flare Slope RT (%)	8.7
N/A	Flare Traversable LT?	Yes	N/A	Flare Traversable RT?	Yes
Yes	Landing Length (in)	60.0	No	DWS Provided?	No
Yes	Landing Width (in)	60.0	N/A	DWS Contrast?	No
No	Landing Slope (%)	2.9	N/A	DWS Length (in)	N/A
Yes	Landing X Slope (%)	1.6	N/A	DWS Full Width?	No
N/A	Landing Curb? (Y/N)	No	N/A	DWS Offset (in)	N/A
N/A	Shared Landing?	No			
Yes	Gutter Ponding?	No	No	Gutter Slope (%)	6.6
Yes	Gutter Lip Ht (in)	0.0	Yes	Gutter X Slope (%)	1.5
N/A	Painted X Walk1?	No	N/A	Painted X Walk2?	N/A
	X Walk 1 Direction	To E		X Walk 2 Direction	N/A
N/A	X Walk 1 Width (in)	N/A	N/A	X Walk 2 Width (in)	N/A
	X Walk 1 Slope (%)	7.8		X Walk 2 Slope (%)	N/A
	X Walk 1 X Slope (%)	3.3		X Walk 2 X Slope (%)	N/A

N/A	Ramp inside XWalk1?	N/A	N/A	Ramp inside XWalk2?	N/A
	Road Slope (%)	N/A	N/A	Clear Space?	Yes
	Road X Slope (%)	N/A	N/A	Clear Space to XWalk (in)	N/A
Yes	Any Obstructions?	No	Yes	Storm Grate/Utility Hazard?	No
	Obstruction Type			Storm Grate/Utility Type	
		N/A			N/A
			Yes	Surface Condition? (G/P)	Good

Possible Solutions:

**Remove & Replace Entire Ramp.
Remove & Replace Gutter.**

**R304.2.2-Perp, R304.3.2-Para, R305,
R304.5.4**
