Access Compliance Report

Public Rights-of-Way

(Curb Ramps)

Intersection ID: 13871	Main Street: E_5TH_ST	Cross Street: HAWTHORNE_LN	Location: SW
ADA ID: 9A98359CC72C	Ramp Type: Perp	Initial Pass/Fail: Pass	Overall Compliance: No
Severity Score: 0			
Codes/Mitigation Info/Possible Solution		Field Measurements/Component Compliance

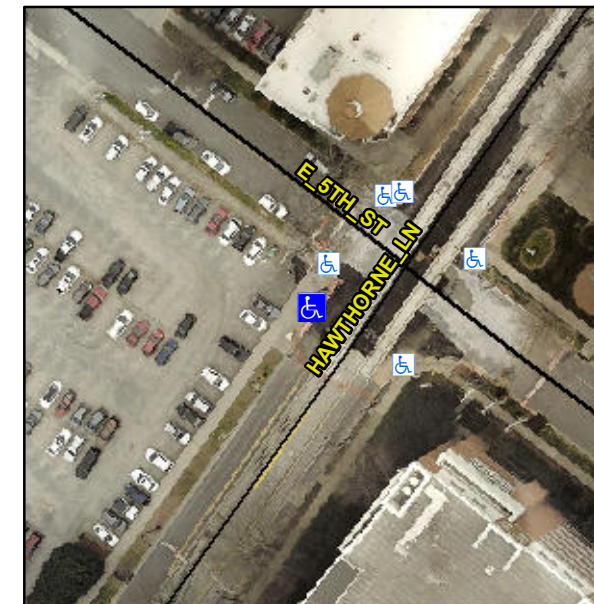
Compliance	Description	Data	Compliance	Description	Data
N/A	Ramp Length (in)	25.5	Yes	Ramp Slope (%)	5.3
Yes	Ramp Width (in)	48.0	Yes	Ramp XSlope (%)	0.5
N/A	Flare Type LT	Sloped	N/A	Flare Type RT	N/A
N/A	Flare Slope LT (%)	7.1	Yes	Flare Slope RT (%)	9.3
N/A	Flare Traversable LT?	Yes	N/A	Flare Traversable RT?	Yes
Yes	Landing Length (in)	71.5	Yes	DWS Provided?	Yes
No	Landing Width (in)	47.5	Yes	DWS Contrast?	Yes
No	Landing Slope (%)	2.6	Yes	DWS Length (in)	25.0
Yes	Landing X Slope (%)	0.1	Yes	DWS Full Width?	Yes
N/A	Landing Curb? (Y/N)	Yes	Yes	DWS Offset (in)	0.0
N/A	Shared Landing?	No			
No	Gutter Ponding?	Yes	Yes	Gutter Slope (%)	3.0
Yes	Gutter Lip Ht (in)	0.0	Yes	Gutter X Slope (%)	1.6
N/A	Painted X Walk1?	Yes	N/A	Painted X Walk2?	N/A
	X Walk 1 Direction	To SE		X Walk 2 Direction	N/A
N/A	X Walk 1 Width (in)	111.5	N/A	X Walk 2 Width (in)	N/A
	X Walk 1 Slope (%)	2.0		X Walk 2 Slope (%)	N/A
	X Walk 1 X Slope (%)	0.0		X Walk 2 X Slope (%)	N/A

Yes	Ramp inside XWalk1?	Yes	N/A	Ramp inside XWalk2?	N/A
	Road Slope (%)	N/A	N/A	Clear Space?	Yes
	Road X Slope (%)	N/A	N/A	Clear Space to XWalk (in)	N/A
Yes	Any Obstructions?	No	Yes	Storm Grate/Utility Hazard?	No
	Obstruction Type			Storm Grate/Utility Type	
		N/A			N/A
			Yes	Surface Condition? (G/P)	Good

Possible Solutions:

Remove & Replace Landing. Gutter Ponding Observed.

R304.2.1, R304.2.2-Perp, R304.3.2-Para, R302.7
