Access Compliance Report

Public Rights-of-Way

(Curb Ramps)

Intersection ID: 48437	Main Street: LATHERTON_LN	Cross Street: CULLEN_CT	Location: SW
ADA ID: 9AA39B18595D	Ramp Type: Perp	Initial Pass/Fail: Fail	Overall Compliance: No
Severity Score: 8.75			
Codes/Mitigation Info/Possible Solution		Field Measurements/Component Compliance

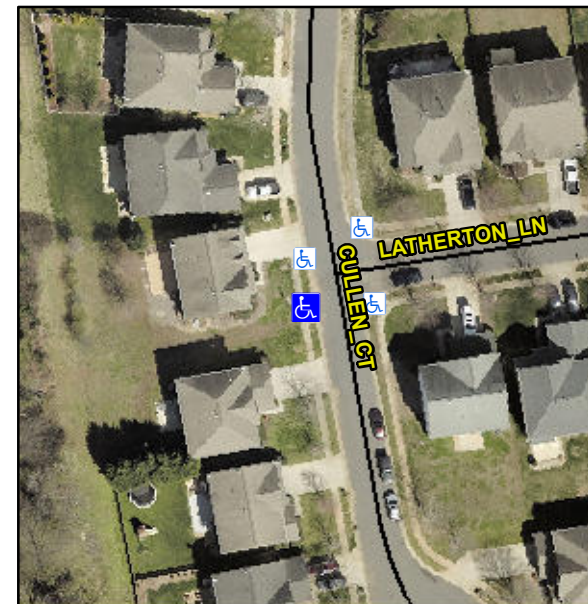
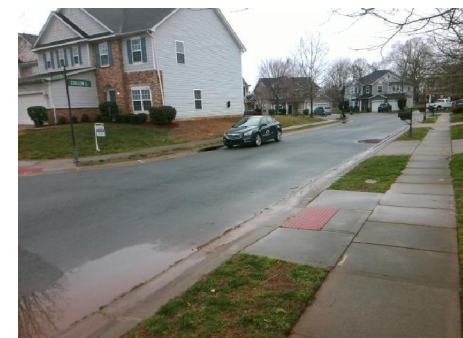
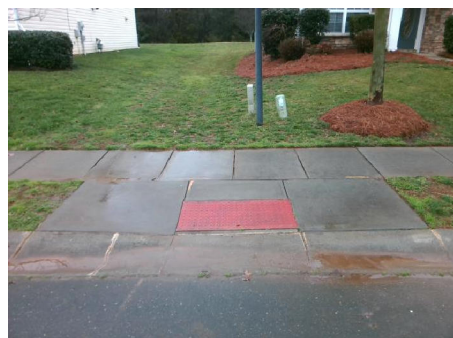
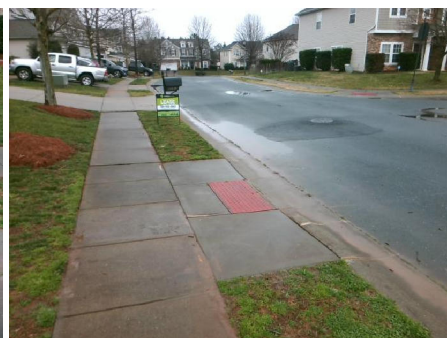
Compliance	Description	Data	Compliance	Description	Data
N/A	Ramp Length (in)	47.0	Yes	Ramp Slope (%)	7.1
No	Ramp Width (in)	47.0	Yes	Ramp XSlope (%)	1.3
N/A	Flare Type LT	N/A	N/A	Flare Type RT	N/A
N/A	Flare Slope LT (%)	N/A	N/A	Flare Slope RT (%)	N/A
N/A	Flare Traversable LT?	N/A	N/A	Flare Traversable RT?	N/A
N/A	Landing Length (in)	N/A	N/A	DWS Provided?	N/A
N/A	Landing Width (in)	N/A	N/A	DWS Contrast?	N/A
N/A	Landing Slope (%)	N/A	N/A	DWS Length (in)	N/A
N/A	Landing X Slope (%)	N/A	N/A	DWS Full Width?	N/A
N/A	Landing Curb? (Y/N)	N/A	N/A	DWS Offset (in)	N/A
N/A	Shared Landing?	N/A			
N/A	Gutter Ponding?	N/A	N/A	Gutter Slope (%)	N/A
N/A	Gutter Lip Ht (in)	N/A	N/A	Gutter X Slope (%)	N/A
N/A	Painted X Walk1?	No	N/A	Painted X Walk2?	N/A
	X Walk 1 Direction	To E		X Walk 2 Direction	N/A
N/A	X Walk 1 Width (in)	N/A	N/A	X Walk 2 Width (in)	N/A
	X Walk 1 Slope (%)	2.1		X Walk 2 Slope (%)	N/A
	X Walk 1 X Slope (%)	1.0		X Walk 2 X Slope (%)	N/A

N/A	Ramp inside XWalk1?	N/A	N/A	Ramp inside XWalk2?	N/A
	Road Slope (%)	N/A	N/A	Clear Space?	N/A
	Road X Slope (%)	N/A	N/A	Clear Space to XWalk (in)	N/A
N/A	Any Obstructions?	N/A	N/A	Storm Grate/Utility Hazard?	N/A
	Obstruction Type			Storm Grate/Utility Type	
		N/A			N/A
		Yes		Surface Condition? (G/P)	Good

Possible Solutions:

Remove & Replace Entire Ramp.

Total Cost: \$ **1850.00**
