# Access Compliance Report

## Public Rights-of-Way

### (Curb Ramps)

Intersection ID: 10011236	Main Street: N_CHURCH_ST	Cross Street: WADSWORTH_PL	Location: E
ADA ID: 9AA60D5C6550	Ramp Type: Directional1	Initial Pass/Fail: Pass	Overall Compliance: No
Severity Score: 0			
Codes/Mitigation Info/Possible Solution		Field Measurements/Component Compliance

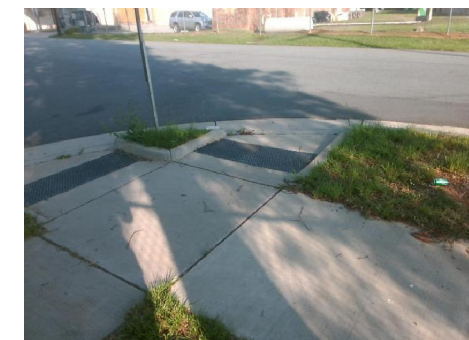
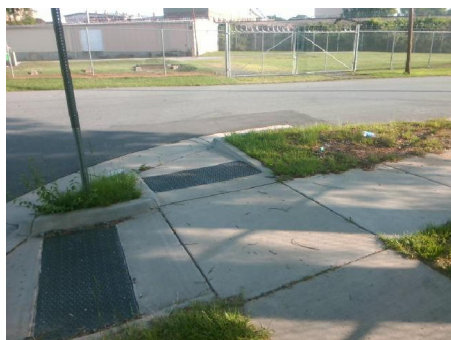
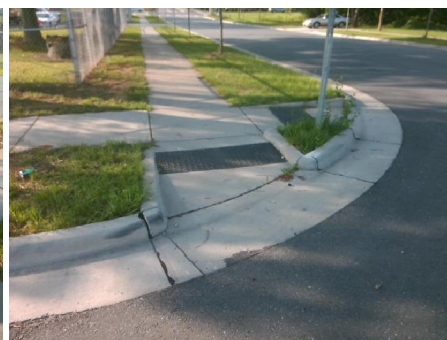
Compliance	Description	Data	Compliance	Description	Data
N/A	Ramp Length (in)	43.0	Yes	Grade Break?	Yes
Yes	Ramp Width (in)	56.0	Yes	Grade Break Slope (%)	0.2
Yes	Ramp Slope (%)	1.1	Yes	Grade Break XSlope (%)	1.8
Yes	Ramp XSlope (%)	0.5			
Yes	Flare Type LT	N/A	Yes	Flare Type RT	N/A
N/A	Flare Slope LT (%)	N/A	N/A	Flare Slope RT (%)	N/A
N/A	Flare Traversable LT?	No	N/A	Flare Traversable RT?	No
Yes	Landing Length (in)	63.0	Yes	DWS Provided?	Yes
Yes	Landing Width (in)	56.0	Yes	DWS Contrast?	Yes
No	Landing Slope (%)	2.8	Yes	DWS Length (in)	24.0
Yes	Landing X Slope (%)	0.7	Yes	DWS Full Width?	Yes
N/A	Landing Curb? (Y/N)	No	Yes	DWS Offset LT (in)	23.0
N/A	Shared Landing?	Yes	No	DWS Offset RT (in)	6.0
Yes	Gutter Ponding?	No	Yes	Gutter Slope (%)	2.0
Yes	Gutter Lip Ht (in)	0.0	Yes	Gutter X Slope (%)	0.2
N/A	Painted X Walk1?	No		Road Slope (%)	2.9
	X Walk 1 Direction	To NW		Road X Slope (%)	0.0
	X Walk 1 Width (in)	N/A		Clear Space?	Yes

X Walk 1 Slope (%)	2.9	N/A	Clear Space to XWalk (in)	N/A
	X Walk 1 X Slope (%)	0.0	Yes	Storm Grate/Utility Hazard?	No
N/A	Ramp inside XWalk1?	N/A		Storm Grate/Utility Type	
Yes	Any Obstructions?	No			N/A
	Obstruction Type		Yes	Surface Condition? (G/P)	Good
			N/A	Curb Slope (%)	9.6

Possible Solutions:

**Remove & Replace Entire Ramp.**
