Access Compliance Report

Public Rights-of-Way

(Curb Ramps)

Intersection ID: 28698	Main Street: OLD_LITTLE_ROCK_RD	Cross Street: HOOVER_CR	Location:	N/A
ADA ID: 9AAD0BFF63B2	Ramp Type: Perp	Initial Pass/Fail: Fail	Overall Compliance: No	Severity Score: 10
Codes/Mitigation Info/Possible Solution		Field Measurements/Component Compliance

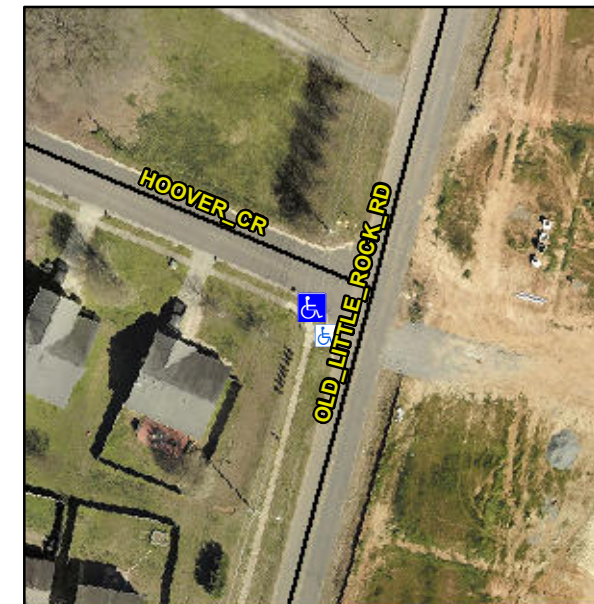
Not Found, R304.5.1, R304.5.3

Compliance	Description	Data	Compliance	Description	Data
N/A	Ramp Length (in)	46.0	Yes	Ramp Slope (%)	5.3
No	Ramp Width (in)	44.0	No	Ramp XSlope (%)	2.6
N/A	Flare Type LT	N/A	N/A	Flare Type RT	N/A
N/A	Flare Slope LT (%)	N/A	N/A	Flare Slope RT (%)	N/A
N/A	Flare Traversable LT?	N/A	N/A	Flare Traversable RT?	N/A
N/A	Landing Length (in)	N/A	N/A	DWS Provided?	N/A
N/A	Landing Width (in)	N/A	N/A	DWS Contrast?	N/A
N/A	Landing Slope (%)	N/A	N/A	DWS Length (in)	N/A
N/A	Landing X Slope (%)	N/A	N/A	DWS Full Width?	N/A
N/A	Landing Curb? (Y/N)	N/A	N/A	DWS Offset (in)	N/A
N/A	Shared Landing?	N/A			
N/A	Gutter Ponding?	N/A	N/A	Gutter Slope (%)	N/A
N/A	Gutter Lip Ht (in)	N/A	N/A	Gutter X Slope (%)	N/A
N/A	Painted X Walk1?	No	N/A	Painted X Walk2?	N/A
	X Walk 1 Direction	To N		X Walk 2 Direction	N/A
N/A	X Walk 1 Width (in)	N/A	N/A	X Walk 2 Width (in)	N/A
	X Walk 1 Slope (%)	4.0		X Walk 2 Slope (%)	N/A
	X Walk 1 X Slope (%)	0.3		X Walk 2 X Slope (%)	N/A

N/A	Ramp inside XWalk1?	N/A	N/A	Ramp inside XWalk2?	N/A
	Road Slope (%)	0.3	N/A	Clear Space?	N/A
	Road X Slope (%)	4.0	N/A	Clear Space to XWalk (in)	N/A
N/A	Any Obstructions?	N/A	N/A	Storm Grate/Utility Hazard?	N/A
	Obstruction Type			Storm Grate/Utility Type	
		N/A			N/A
			Yes	Surface Condition? (G/P)	Good

Possible Solutions:

Remove & Replace Entire Ramp.
