# Access Compliance Report

## Public Rights-of-Way

### (Curb Ramps)

| Intersection ID: 5904 | Main Street: COULWOOD_DR | Cross Street: MELLWOOD_DR | Location: | W |

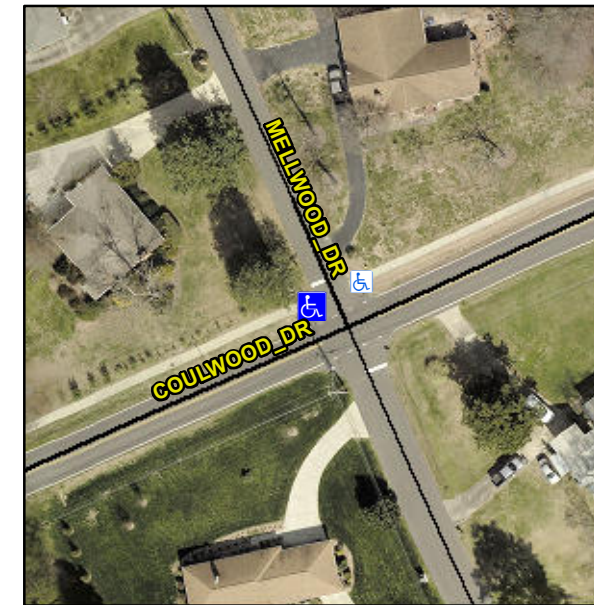
| ADA ID: 9AAF7B3BEB4A | Ramp Type: Directional1 | Initial Pass/Fail: Pass | Overall Compliance: No | Severity Score: 7.5 |

**R304.2.2-Perp, R304.3.2-Para,**  
**R304.5.3, R305.1.4, R305.2, R304.5.4**

| Compliance | Description | Data | Compliance | Description | Data |
|---|---|---|---|---|---|
| Yes | Ramp Slope (%) | 5.2 | No | Grade Break XSlope (%) | 2.9 |
| No | Landing Slope (%) | 7.0 | Yes | DWS Length (in) | 24.0 |
| Yes | Landing X Slope (%) | 0.2 | No | DWS Full Width? | No |
| Yes | Gutter Ponding? | No | No | Gutter Slope (%) | 5.3 |
| Yes | Gutter Lip Ht (in) | 0.0 | No | Gutter X Slope (%) | 4.5 |

**Remove & Replace Entire Ramp.**  
**Remove & Replace Gutter.**

Total Cost: \$ 2350.00
