Access Compliance Report

Public Rights-of-Way

(Curb Ramps)

Intersection ID: 10003849	Main Street: DIXIE_RIVER_RD	Cross Street: NEW_FASHION_WY	Location: NE
ADA ID: 9AB72A668DF4	Ramp Type: Perp	Initial Pass/Fail: Fail	Overall Compliance: No
Severity Score: 12.5			
Codes/Mitigation Info/Possible Solution		Field Measurements/Component Compliance

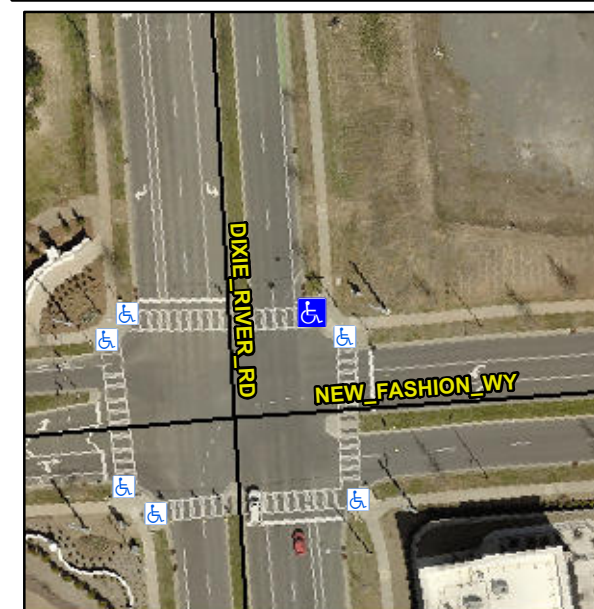
Not Found, R304.2.2

Compliance	Description	Data	Compliance	Description	Data
N/A	Ramp Length (in)	71.0	No	Ramp Slope (%)	8.5
Yes	Ramp Width (in)	48.0	Yes	Ramp XSlope (%)	0.4
N/A	Flare Type LT	N/A	N/A	Flare Type RT	N/A
N/A	Flare Slope LT (%)	N/A	N/A	Flare Slope RT (%)	N/A
N/A	Flare Traversable LT?	N/A	N/A	Flare Traversable RT?	N/A
N/A	Landing Length (in)	N/A	N/A	DWS Provided?	N/A
N/A	Landing Width (in)	N/A	N/A	DWS Contrast?	N/A
N/A	Landing Slope (%)	N/A	N/A	DWS Length (in)	N/A
N/A	Landing X Slope (%)	N/A	N/A	DWS Full Width?	N/A
N/A	Landing Curb? (Y/N)	N/A	N/A	DWS Offset (in)	N/A
N/A	Shared Landing?	N/A			
N/A	Gutter Ponding?	N/A	N/A	Gutter Slope (%)	N/A
N/A	Gutter Lip Ht (in)	N/A	N/A	Gutter X Slope (%)	N/A
N/A	Painted X Walk1?	Yes	N/A	Painted X Walk2?	N/A
	X Walk 1 Direction	To W		X Walk 2 Direction	N/A
N/A	X Walk 1 Width (in)	113.0	N/A	X Walk 2 Width (in)	N/A
	X Walk 1 Slope (%)	0.8		X Walk 2 Slope (%)	N/A
	X Walk 1 X Slope (%)	0.7		X Walk 2 X Slope (%)	N/A

N/A	Ramp inside XWalk1?	Yes	N/A	Ramp inside XWalk2?	N/A
	Road Slope (%)	N/A	N/A	Clear Space?	N/A
	Road X Slope (%)	N/A	N/A	Clear Space to XWalk (in)	N/A
N/A	Any Obstructions?	N/A	N/A	Storm Grate/Utility Hazard?	N/A
	Obstruction Type			Storm Grate/Utility Type	
		N/A			N/A
		Yes		Surface Condition? (G/P)	Good

Remove & Replace Entire Ramp.

Total Cost: \$ 1850.00
