Access Compliance Report

Public Rights-of-Way

(Curb Ramps)

Intersection ID: 46994	Main Street: SWEARNGAN_RIDGE_CT	Cross Street: SWEARNGAN_RD	Location: NW
ADA ID: 9AB920372CF6	Ramp Type: BlendTrans1	Initial Pass/Fail: Fail	Overall Compliance: No
		Severity Score: 10

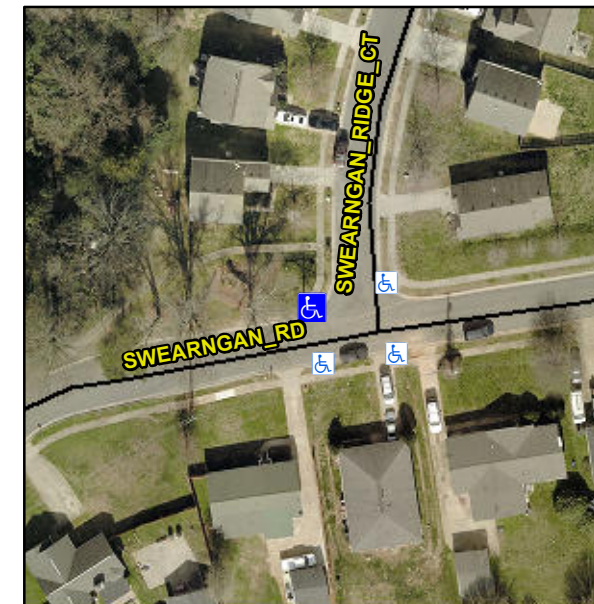
NO LT SW

Compliance	Description	Data	Compliance	Description	Data
N/A	Ramp Length (in)	42.0	Yes	BlendTrans Slope (%)	2.2
No	Ramp Width (in)	46.5	Yes	BlendTrans XSlope (%)	3.7
N/A	Flare Type LT	N/A	N/A	Flare Type RT	N/A
N/A	Flare Slope LT (%)	N/A	N/A	Flare Slope RT (%)	N/A
N/A	Flare Traversable LT?	N/A	N/A	Flare Traversable RT?	N/A
N/A	Landing Length (in)	N/A	N/A	DWS Provided?	N/A
N/A	Landing Width (in)	N/A	N/A	DWS Contrast?	N/A
N/A	Landing Slope (%)	N/A	N/A	DWS Length (in)	N/A
N/A	Landing X Slope (%)	N/A	N/A	DWS Full Width?	N/A
N/A	Landing Curb? (Y/N)	N/A	N/A	DWS Offset (in)	N/A
N/A	Shared Landing?	N/A			
N/A	Gutter Ponding?	N/A	N/A	Gutter Slope (%)	N/A
N/A	Gutter Lip Ht (in)	N/A	N/A	Gutter X Slope (%)	N/A
N/A	Painted X Walk1?	No	N/A	Painted X Walk2?	No
	X Walk 1 Direction	To S		X Walk 2 Direction	To NW
	X Walk 1 Width (in)	N/A		X Walk 2 Width (in)	N/A
	X Walk 1 Slope (%)	N/A		X Walk 2 Slope (%)	3.5
	X Walk 1 X Slope (%)	N/A		X Walk 2 X Slope (%)	0.7

N/A	Ramp inside XWalk1?	N/A	N/A	Ramp inside XWalk2?	N/A
	Road Slope (%)	N/A		Clear Space?	N/A
	Road X Slope (%)	N/A	N/A	Clear Space to XWalk (in)	N/A
N/A	Any Obstructions?	N/A	N/A	Storm Grate/Utility Hazard?	N/A
	Obstruction Type			Storm Grate/Utility Type	
		N/A			N/A
			Yes	Surface Condition? (G/P)	Good
			N/A	Curb Slope (%)	1.4

Remove & Replace Curb Ramp With Two New Directional Ramps or Equivalent.

R304.5.1
