Access Compliance Report

Public Rights-of-Way

(Curb Ramps)

Intersection ID: 25211	Main Street: SMITH_RD	Cross Street: SOUTHBRIDGE_FOREST_DR	Location: SW
ADA ID: 9AC317D6E7D5	Ramp Type: Perp	Initial Pass/Fail: Fail	Overall Compliance: No
		Severity Score: 12.5

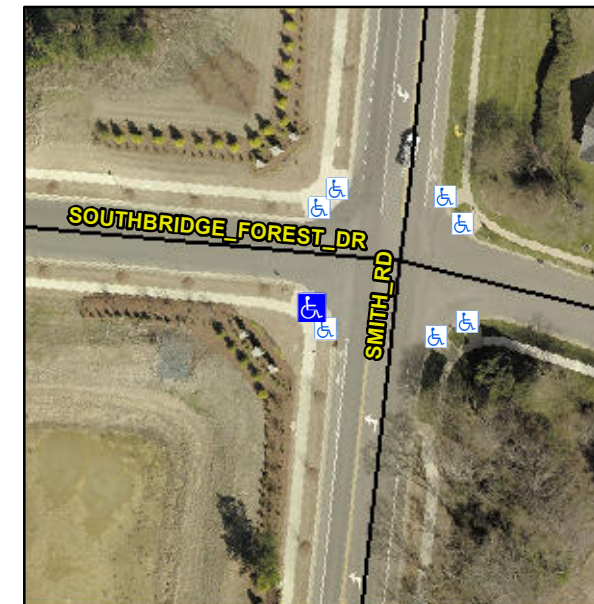
Not Found, R304.5.3

Compliance	Description	Data	Compliance	Description	Data
N/A	Ramp Length (in)	97.0	Yes	Ramp Slope (%)	6.0
Yes	Ramp Width (in)	48.0	No	Ramp XSlope (%)	6.3
N/A	Flare Type LT	N/A	N/A	Flare Type RT	N/A
N/A	Flare Slope LT (%)	N/A	N/A	Flare Slope RT (%)	N/A
N/A	Flare Traversable LT?	N/A	N/A	Flare Traversable RT?	N/A
N/A	Landing Length (in)	N/A	N/A	DWS Provided?	N/A
N/A	Landing Width (in)	N/A	N/A	DWS Contrast?	N/A
N/A	Landing Slope (%)	N/A	N/A	DWS Length (in)	N/A
N/A	Landing X Slope (%)	N/A	N/A	DWS Full Width?	N/A
N/A	Landing Curb? (Y/N)	N/A	N/A	DWS Offset (in)	N/A
N/A	Shared Landing?	N/A			
N/A	Gutter Ponding?	N/A	N/A	Gutter Slope (%)	N/A
N/A	Gutter Lip Ht (in)	N/A	N/A	Gutter X Slope (%)	N/A
N/A	Painted X Walk1?	No	N/A	Painted X Walk2?	N/A
	X Walk 1 Direction	To NE		X Walk 2 Direction	N/A
N/A	X Walk 1 Width (in)	N/A	N/A	X Walk 2 Width (in)	N/A
	X Walk 1 Slope (%)	1.0		X Walk 2 Slope (%)	N/A
	X Walk 1 X Slope (%)	4.0		X Walk 2 X Slope (%)	N/A

N/A	Ramp inside XWalk1?	N/A	N/A	Ramp inside XWalk2?	N/A
	Road Slope (%)	N/A	N/A	Clear Space?	N/A
	Road X Slope (%)	N/A	N/A	Clear Space to XWalk (in)	N/A
N/A	Any Obstructions?	N/A	N/A	Storm Grate/Utility Hazard?	N/A
	Obstruction Type			Storm Grate/Utility Type	
		N/A			N/A
			Yes	Surface Condition? (G/P)	Good

Possible Solutions:

Remove & Replace Entire Ramp.

Total Cost: \$ 1850.00
