Access Compliance Report Public Rights-of-Way (Curb Ramps)

Intersection ID: 10033082 Main Street: NORTH REA PARK LN **Cross Street: N/A** Location:

ADA ID: 9AC5624311DD Ramp Type: Perp Initial Pass/Fail: Fail **Overall Compliance: No** Severity Score: 13.75

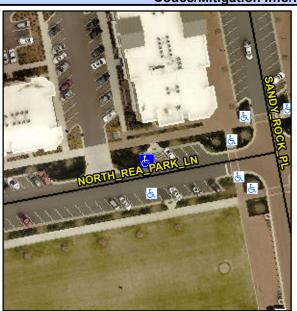
Possible Solutions:	Compli	ance	Description
Remove & Replace Entire Ramp.	N/A	Ram	c Length (in)
·	Yes	Ram	o Width (in)
	N/A	Flare	Type LT
	N/A	Flare	Slope LT (%)
	N/A	Flare	Traversable LT
	N/A	Land	ing Length (in)
Surveyor Notes:	N/A	Land	ing Width (in)
N/A	N/A	Land	ing Slope (%)
	N/A	Land	ing X Slope (%)
	N/A	Land	ing Curb? (Y/N)
	N/A	Share	ed Landing?
PROW/ADA:	N/A	Gutte	er Ponding?
Not Found, R304.2.2, R304.5.3	N/A	Gutte	er Lip Ht (in)
	N/A	Paint	ed X Walk1?
		X Wa	lk 1 Direction
	N/A	X Wa	lk 1 Width (in)
		X Wa	lk 1 Slope (%)
		X Wa	lk 1 X Slope (%
	N/A	Ram	o inside XWalk1
		Road	Slope (%)

N/A	Any Obstructions?	N/A	N/A	Storm Grate/Utility Hazard?	N/A
Total Cost:	\$	1850.00		Obstruction Type		l	Storm Grate/Utility Type	
					N/A			N/A
						Yes	Surface Condition? (G/P)	Good
