# Access Compliance Report

## Public Rights-of-Way

| Intersection ID: 21458 | Main Street: PROVIDENCE_RD | Cross Street: SARDIS_LN | Location: SE |
| ADA ID: 9AC836120DB8 | Ramp Type: PerpDiag | Initial Pass/Fail: Fail | Overall Compliance: No |

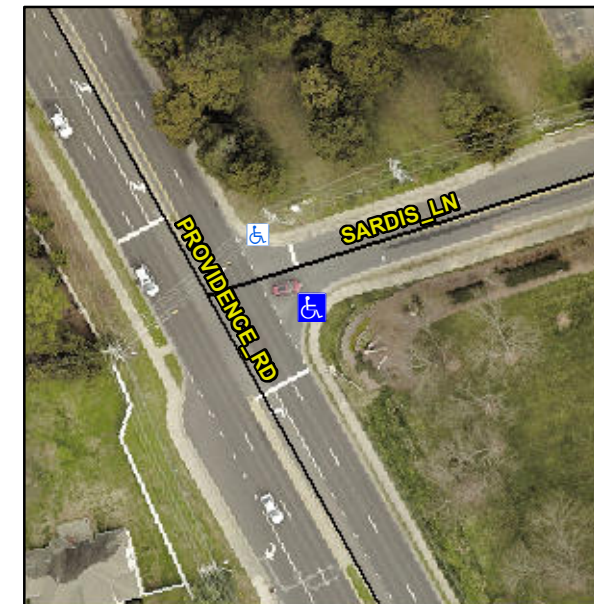
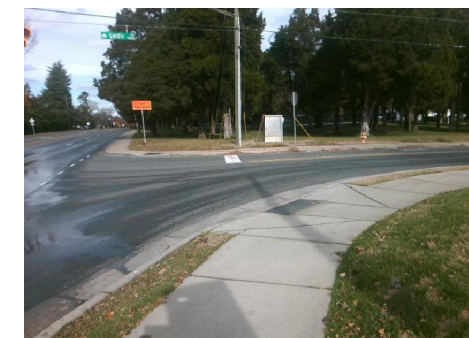
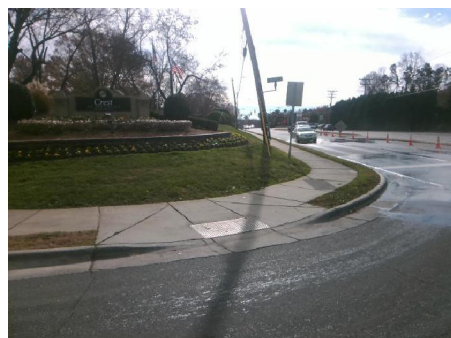
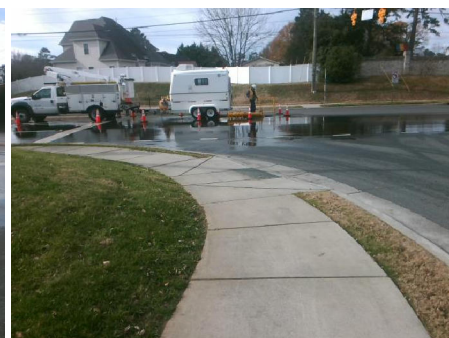
**Not Found, R304.5.1, R304.2.2, R304.5.3**

| Compliance | Description | Data | Compliance | Description | Data |
|---|---|---|---|---|---|
| N/A | Ramp Length (in) | 85.0 | No | Ramp Slope (%) | 9.2 |
| No | Ramp Width (in) | 33.0 | No | Ramp XSlope (%) | 2.7 |

**Remove & Replace Curb Ramp With Two New Directional Ramps or Equivalent.**

Total Cost: \$ 3200.00
