Access Compliance Report

Public Rights-of-Way

(Curb Ramps)

Intersection ID: 11017	Main Street: DRUMMOND_AV	Cross Street: PARSON_ST	Location: S
ADA ID: 9ACAFE5722D2	Ramp Type: Perp	Initial Pass/Fail: Fail	Overall Compliance: No
Severity Score: 50			
Codes/Mitigation Info/Possible Solution		Field Measurements/Component Compliance

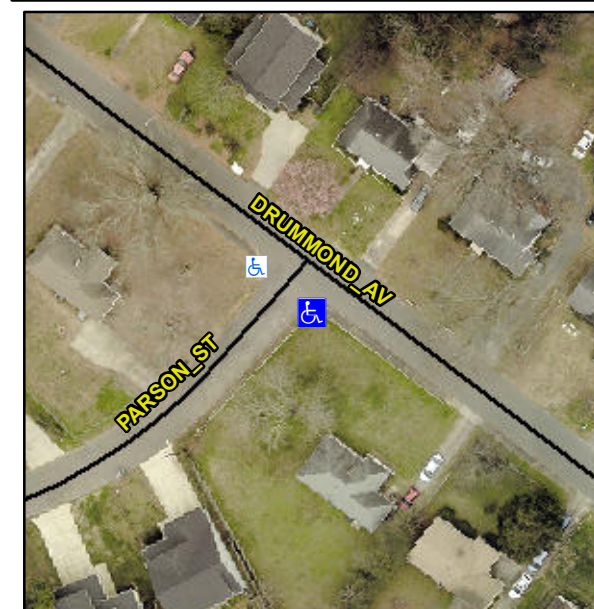
Not Found, R304.2.2, R304.5.3

Compliance	Description	Data	Compliance	Description	Data
N/A	Ramp Length (in)	41.5	No	Ramp Slope (%)	15.8
Yes	Ramp Width (in)	50.0	No	Ramp XSlope (%)	12.2
N/A	Flare Type LT	N/A	N/A	Flare Type RT	N/A
N/A	Flare Slope LT (%)	N/A	N/A	Flare Slope RT (%)	N/A
N/A	Flare Traversable LT?	N/A	N/A	Flare Traversable RT?	N/A
N/A	Landing Length (in)	N/A	N/A	DWS Provided?	N/A
N/A	Landing Width (in)	N/A	N/A	DWS Contrast?	N/A
N/A	Landing Slope (%)	N/A	N/A	DWS Length (in)	N/A
N/A	Landing X Slope (%)	N/A	N/A	DWS Full Width?	N/A
N/A	Landing Curb? (Y/N)	N/A	N/A	DWS Offset (in)	N/A
N/A	Shared Landing?	N/A			
N/A	Gutter Ponding?	N/A	N/A	Gutter Slope (%)	N/A
N/A	Gutter Lip Ht (in)	N/A	N/A	Gutter X Slope (%)	N/A
N/A	Painted X Walk1?	No	N/A	Painted X Walk2?	N/A
	X Walk 1 Direction	To NW		X Walk 2 Direction	N/A
N/A	X Walk 1 Width (in)	N/A	N/A	X Walk 2 Width (in)	N/A
	X Walk 1 Slope (%)	4.3		X Walk 2 Slope (%)	N/A
	X Walk 1 X Slope (%)	4.3		X Walk 2 X Slope (%)	N/A

N/A	Ramp inside XWalk1?	N/A	N/A	Ramp inside XWalk2?	N/A
	Road Slope (%)	N/A	N/A	Clear Space?	N/A
	Road X Slope (%)	N/A	N/A	Clear Space to XWalk (in)	N/A
N/A	Any Obstructions?	N/A	N/A	Storm Grate/Utility Hazard?	N/A
	Obstruction Type			Storm Grate/Utility Type	
		N/A			N/A
			Yes	Surface Condition? (G/P)	Good

Remove & Replace Entire Ramp.

Total Cost: \$ 1850.00
