# Access Compliance Report

## Public Rights-of-Way

### (Curb Ramps)

Intersection ID: 30281	Main Street: BLYTHEDALE_DR	Cross Street: ELSBERRY_LN	Location: S
ADA ID: 9ACE0ACD979B	Ramp Type: PerpDiag	Initial Pass/Fail: Fail	Overall Compliance: No
Severity Score: 33.75			
Codes/Mitigation Info/Possible Solution		Field Measurements/Component Compliance

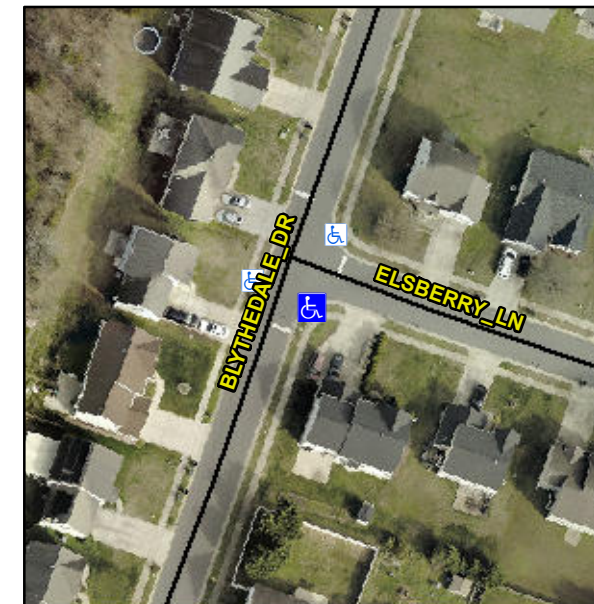
**Not Found, R304.5.1, R304.5.3**

Compliance	Description	Data	Compliance	Description	Data
N/A	Ramp Length (in)	48.0	Yes	Ramp Slope (%)	5.1
No	Ramp Width (in)	43.0	No	Ramp XSlope (%)	8.7
N/A	Flare Type LT	N/A	N/A	Flare Type RT	N/A
N/A	Flare Slope LT (%)	N/A	N/A	Flare Slope RT (%)	N/A
N/A	Flare Traversable LT?	N/A	N/A	Flare Traversable RT?	N/A
N/A	Landing Length (in)	N/A	N/A	DWS Provided?	N/A
N/A	Landing Width (in)	N/A	N/A	DWS Contrast?	N/A
N/A	Landing Slope (%)	N/A	N/A	DWS Length (in)	N/A
N/A	Landing X Slope (%)	N/A	N/A	DWS Full Width?	N/A
N/A	Landing Curb? (Y/N)	N/A	N/A	DWS Offset (in)	N/A
N/A	Shared Landing?	N/A			
N/A	Gutter Ponding?	N/A	N/A	Gutter Slope (%)	N/A
N/A	Gutter Lip Ht (in)	N/A	N/A	Gutter X Slope (%)	N/A
N/A	Painted X Walk1?	No	N/A	Painted X Walk2?	No
	X Walk 1 Direction	To E		X Walk 2 Direction	To W
N/A	X Walk 1 Width (in)	N/A	N/A	X Walk 2 Width (in)	N/A
	X Walk 1 Slope (%)	5.8		X Walk 2 Slope (%)	4.6
	X Walk 1 X Slope (%)	4.3		X Walk 2 X Slope (%)	6.1

N/A	Ramp inside XWalk1?	N/A	N/A	Ramp inside XWalk2?	N/A
	Road Slope (%)	7.5	N/A	Clear Space?	N/A
	Road X Slope (%)	1.4	N/A	Clear Space to XWalk (in)	N/A
N/A	Any Obstructions?	N/A	N/A	Storm Grate/Utility Hazard?	N/A
	Obstruction Type			Storm Grate/Utility Type	
		N/A			N/A
		Yes		Surface Condition? (G/P)	Good

**Remove & Replace Curb Ramp With Two New Directional Ramps or Equivalent.**
