Access Compliance Report

Public Rights-of-Way

(Curb Ramps)

Intersection ID: 31506	Main Street: CHARIDGE_LN	Cross Street: STONEY_CREEK_LN	Location: NE
ADA ID: 9AD5D8921970	Ramp Type: PerpDiag	Initial Pass/Fail: Fail	Overall Compliance: No
Severity Score: 22.5			
Codes/Mitigation Info/Possible Solution		Field Measurements/Component Compliance

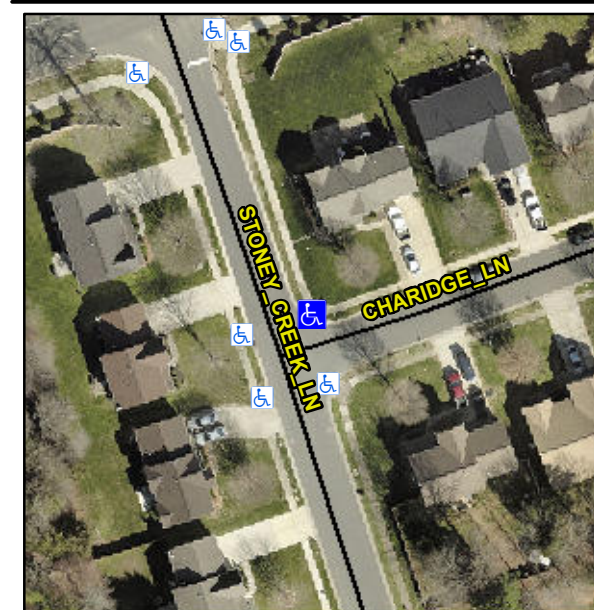
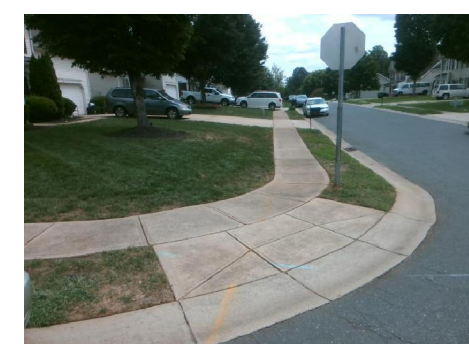
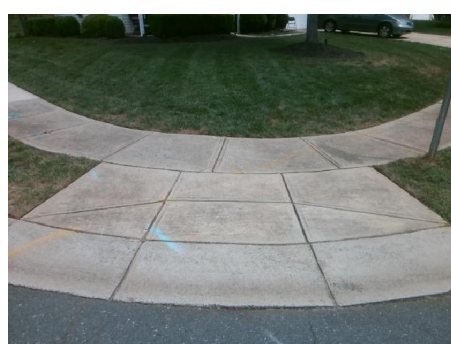
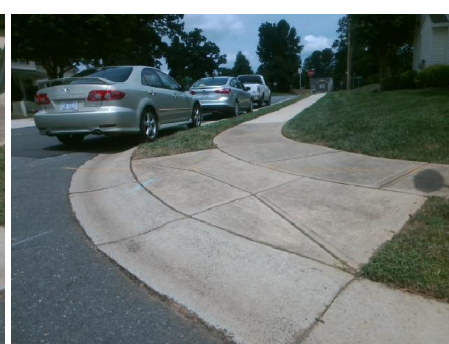
Not Found, R304.5.1, R304.2.2, R304.5.3

Compliance	Description	Data	Compliance	Description	Data
N/A	Ramp Length (in)	47.0	No	Ramp Slope (%)	9.0
No	Ramp Width (in)	43.5	No	Ramp XSlope (%)	3.1
N/A	Flare Type LT	N/A	N/A	Flare Type RT	N/A
N/A	Flare Slope LT (%)	N/A	N/A	Flare Slope RT (%)	N/A
N/A	Flare Traversable LT?	N/A	N/A	Flare Traversable RT?	N/A
N/A	Landing Length (in)	N/A	N/A	DWS Provided?	N/A
N/A	Landing Width (in)	N/A	N/A	DWS Contrast?	N/A
N/A	Landing Slope (%)	N/A	N/A	DWS Length (in)	N/A
N/A	Landing X Slope (%)	N/A	N/A	DWS Full Width?	N/A
N/A	Landing Curb? (Y/N)	N/A	N/A	DWS Offset (in)	N/A
N/A	Shared Landing?	N/A			
N/A	Gutter Ponding?	N/A	N/A	Gutter Slope (%)	N/A
N/A	Gutter Lip Ht (in)	N/A	N/A	Gutter X Slope (%)	N/A
N/A	Painted X Walk1?	No	N/A	Painted X Walk2?	No
	X Walk 1 Direction	To W		X Walk 2 Direction	To S
N/A	X Walk 1 Width (in)	N/A	N/A	X Walk 2 Width (in)	N/A
	X Walk 1 Slope (%)	3.8		X Walk 2 Slope (%)	0.0
	X Walk 1 X Slope (%)	2.2		X Walk 2 X Slope (%)	2.9

N/A	Ramp inside XWalk1?	N/A	N/A	Ramp inside XWalk2?	N/A
	Road Slope (%)	3.3	N/A	Clear Space?	N/A
	Road X Slope (%)	6.5	N/A	Clear Space to XWalk (in)	N/A
N/A	Any Obstructions?	N/A	N/A	Storm Grate/Utility Hazard?	N/A
	Obstruction Type			Storm Grate/Utility Type	
		N/A			N/A
			Yes	Surface Condition? (G/P)	Good

Possible Solutions:

Remove & Replace Curb Ramp With Two New Directional Ramps or Equivalent.
