Access Compliance Report

Public Rights-of-Way

(Curb Ramps)

Intersection ID: 32173	Main Street: PROVINCETOWNE_DR	Cross Street: RAYNOR_RD	Location: NW
ADA ID: 9AD75E7FF751	Ramp Type: BlendTrans1	Initial Pass/Fail: Fail	Overall Compliance: No
Severity Score: 8.75			
Codes/Mitigation Info/Possible Solution		Field Measurements/Component Compliance

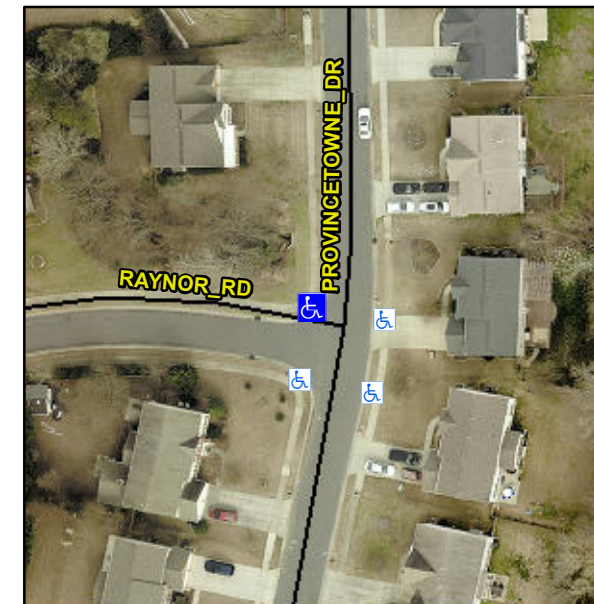
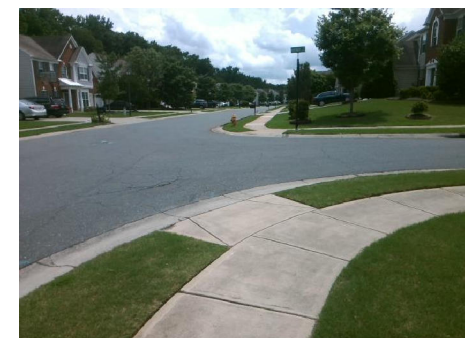
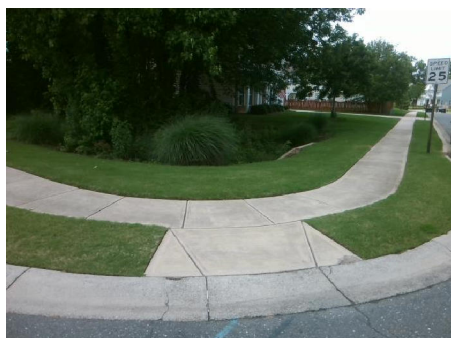
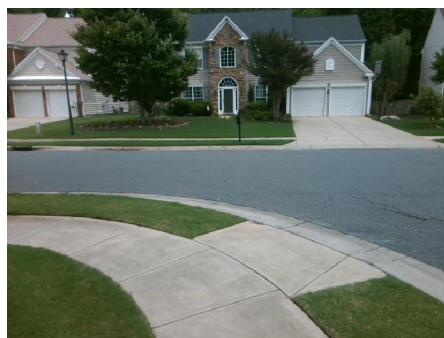
Not Found, R304.5.1

Compliance	Description	Data	Compliance	Description	Data
N/A	Ramp Length (in)	46.0	Yes	BlendTrans Slope (%)	3.1
No	Ramp Width (in)	46.0	Yes	BlendTrans XSlope (%)	1.8
N/A	Flare Type LT	N/A	N/A	Flare Type RT	N/A
N/A	Flare Slope LT (%)	N/A	N/A	Flare Slope RT (%)	N/A
N/A	Flare Traversable LT?	N/A	N/A	Flare Traversable RT?	N/A
N/A	Landing Length (in)	N/A	N/A	DWS Provided?	N/A
N/A	Landing Width (in)	N/A	N/A	DWS Contrast?	N/A
N/A	Landing Slope (%)	N/A	N/A	DWS Length (in)	N/A
N/A	Landing X Slope (%)	N/A	N/A	DWS Full Width?	N/A
N/A	Landing Curb? (Y/N)	N/A	N/A	DWS Offset (in)	N/A
N/A	Shared Landing?	N/A			
N/A	Gutter Ponding?	N/A	N/A	Gutter Slope (%)	N/A
N/A	Gutter Lip Ht (in)	N/A	N/A	Gutter X Slope (%)	N/A
N/A	Painted X Walk1?	No	N/A	Painted X Walk2?	No
	X Walk 1 Direction	To S		X Walk 2 Direction	To E
	X Walk 1 Width (in)	N/A		X Walk 2 Width (in)	N/A
	X Walk 1 Slope (%)	2.8		X Walk 2 Slope (%)	0.9
	X Walk 1 X Slope (%)	1.7		X Walk 2 X Slope (%)	0.7

N/A	Ramp inside XWalk1?	N/A	N/A	Ramp inside XWalk2?	N/A
	Road Slope (%)	0.4		Clear Space?	N/A
	Road X Slope (%)	3.0	N/A	Clear Space to XWalk (in)	N/A
N/A	Any Obstructions?	N/A	N/A	Storm Grate/Utility Hazard?	N/A
	Obstruction Type			Storm Grate/Utility Type	
		N/A			N/A
		Yes		Surface Condition? (G/P)	Good
		No		Curb Slope (%)	12.2

Remove & Replace Curb Ramp With Two New Directional Ramps or Equivalent.

Total Cost: \$ 3200.00
