# Access Compliance Report

## Public Rights-of-Way

### (Curb Ramps)

Intersection ID: 15882	Main Street: EAST_BV	Cross Street: QUEENS_RD_WEST	Location: W
ADA ID: 9ADA6E3E8377	Ramp Type: Directional1	Initial Pass/Fail: Pass	Overall Compliance: No
Severity Score: 0			
Codes/Mitigation Info/Possible Solution		Field Measurements/Component Compliance

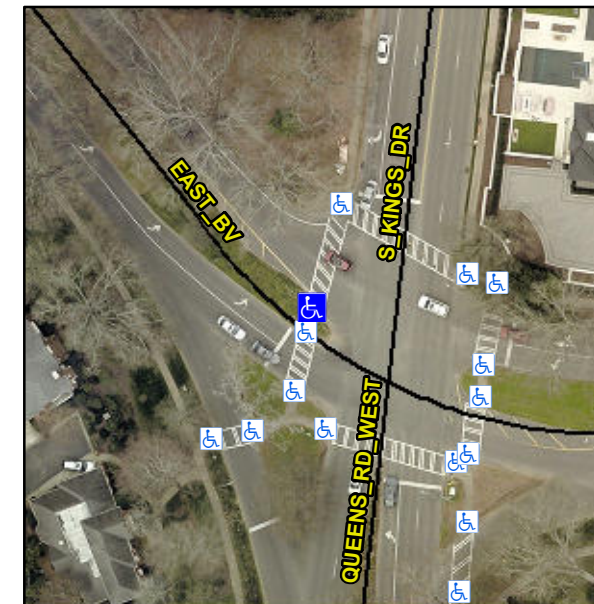
Compliance	Description	Data	Compliance	Description	Data
N/A	Ramp Length (in)	60.0	No	Grade Break?	No
Yes	Ramp Width (in)	48.0	N/A	Grade Break Slope (%)	2.5
Yes	Ramp Slope (%)	5.6	N/A	Grade Break XSlope (%)	3.5
Yes	Ramp XSlope (%)	1.9			
N/A	Flare Type LT	N/A	N/A	Flare Type RT	N/A
N/A	Flare Slope LT (%)	6.2	N/A	Flare Slope RT (%)	5.5
N/A	Flare Traversable LT?	No	N/A	Flare Traversable RT?	No
No	Landing Length (in)	35.0	Yes	DWS Provided?	Yes
Yes	Landing Width (in)	48.0	Yes	DWS Contrast?	Yes
Yes	Landing Slope (%)	0.0	Yes	DWS Length (in)	25.0
Yes	Landing X Slope (%)	0.2	Yes	DWS Full Width?	Yes
N/A	Landing Curb? (Y/N)	N/A	No	DWS Offset LT (in)	3.0
N/A	Shared Landing?	Yes	Yes	DWS Offset RT (in)	39.0
Yes	Gutter Ponding?	No	Yes	Gutter Slope (%)	0.2
Yes	Gutter Lip Ht (in)	0.0	Yes	Gutter X Slope (%)	0.3
N/A	Painted X Walk1?	Yes		Road Slope (%)	1.4
	X Walk 1 Direction	To N		Road X Slope (%)	1.4
	X Walk 1 Width (in)	99.5		Clear Space?	Yes

X Walk 1 Slope (%)	1.4	N/A	Clear Space to XWalk (in)	N/A
	X Walk 1 X Slope (%)	1.4	Yes	Storm Grate/Utility Hazard?	No
Yes	Ramp inside XWalk1?	Yes		Storm Grate/Utility Type	
Yes	Any Obstructions?	No			N/A
	Obstruction Type		Yes	Surface Condition? (G/P)	Good
			N/A	Curb Slope (%)	5.3

Possible Solutions:

**Remove & Replace Entire Ramp.**

**R304.2.1, R304.5.2, R305.2**

Total Cost: \$ 1600.00
