Access Compliance Report

Public Rights-of-Way

(Curb Ramps)

Intersection ID: 10027310	Main Street: GLENEAGLES_RD	Cross Street: N/A	Location: SW
ADA ID: 9AE0C6D88031	Ramp Type: PerpDiag	Initial Pass/Fail: Fail	Overall Compliance: No
			Severity Score: 21.25

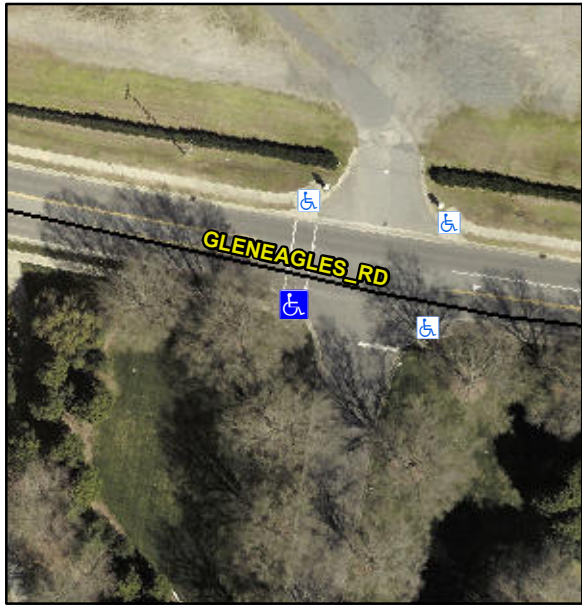
Possible Solutions:		Compliance	Description	Data	Compliance	Description	Data
	Remove & Replace Curb Ramp With Two New Directional Ramps or Equivalent.		N/A	Ramp Length (in)	60.0	No	Ramp Slope (%)	11.0
			No	Ramp Width (in)	42.0	Yes	Ramp XSlope (%)	1.1
			N/A	Flare Type LT	N/A	N/A	Flare Type RT	N/A
			N/A	Flare Slope LT (%)	N/A	N/A	Flare Slope RT (%)	N/A
			N/A	Flare Traversable LT?	N/A	N/A	Flare Traversable RT?	N/A
			N/A	Landing Length (in)	N/A	N/A	DWS Provided?	N/A
			N/A	Landing Width (in)	N/A	N/A	DWS Contrast?	N/A
			N/A	Landing Slope (%)	N/A	N/A	DWS Length (in)	N/A
			N/A	Landing X Slope (%)	N/A	N/A	DWS Full Width?	N/A
Surveyor Notes:	N/A		N/A	Landing Curb? (Y/N)	N/A	N/A	DWS Offset (in)	N/A
			N/A	Shared Landing?	N/A			
			N/A	Gutter Ponding?	N/A	N/A	Gutter Slope (%)	N/A
			N/A	Gutter Lip Ht (in)	N/A	N/A	Gutter X Slope (%)	N/A

N/A	Painted X Walk1?	No	N/A	Painted X Walk2?	Yes
				X Walk 1 Direction	To E		X Walk 2 Direction	To N
			N/A	X Walk 1 Width (in)	N/A	N/A	X Walk 2 Width (in)	124.0
				X Walk 1 Slope (%)	2.8		X Walk 2 Slope (%)	4.1
				X Walk 1 X Slope (%)	0.5		X Walk 2 X Slope (%)	2.4
			N/A	Ramp inside XWalk1?	N/A	N/A	Ramp inside XWalk2?	Yes
PROW/ADA:	R304.5.1, R304.2.2			Road Slope (%)	1.6	N/A	Clear Space?	N/A
				Road X Slope (%)	0.4	N/A	Clear Space to XWalk (in)	N/A
			N/A	Any Obstructions?	N/A	N/A	Storm Grate/Utility Hazard?	N/A
				Obstruction Type			Storm Grate/Utility Type	
					N/A			N/A
						Yes	Surface Condition? (G/P)	Good
Street 1 Name		ENTRANCE						
Stop Condition-Street 2		None						
Street 2 Name		GLENEAGLES RD						
Stop Condition-Street 1		None						
Total Cost:		\$ 3200.00
