# Access Compliance Report

## Public Rights-of-Way

### (Curb Ramps)

| Intersection ID: 30162 | Main Street: HEWITT_DR | Cross Street: MENTONE_LN | Location: SW |

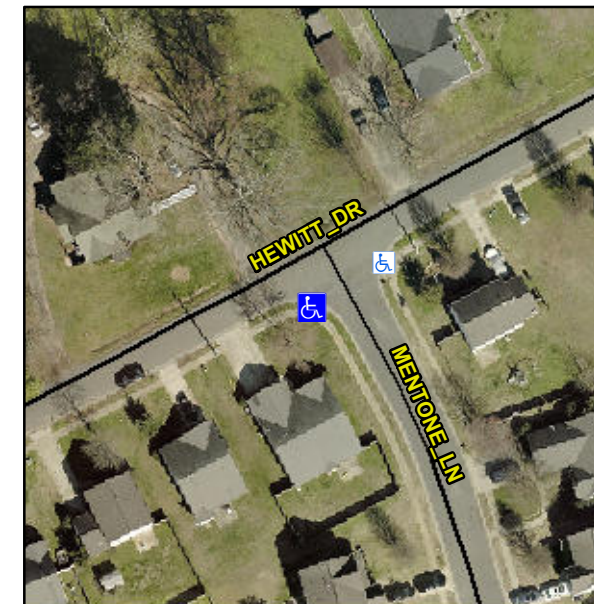
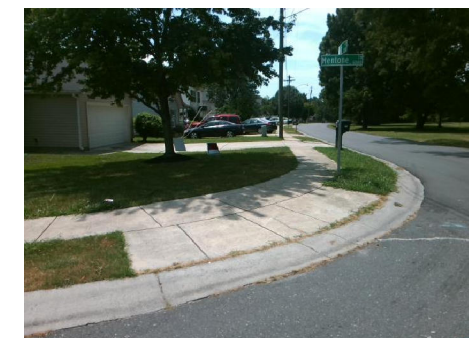
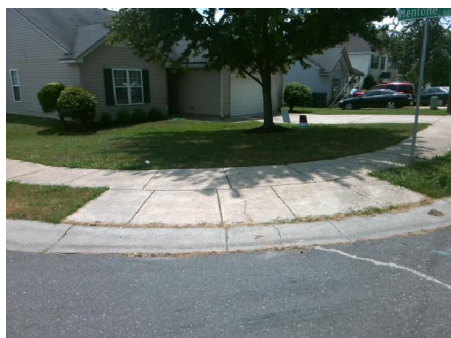
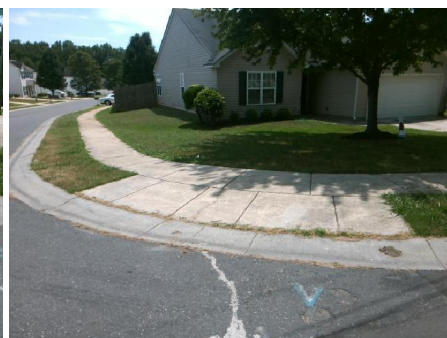
| ADA ID: 9AEE86F298BE | Ramp Type: Perp | Initial Pass/Fail: Fail | Overall Compliance: No |
| Severity Score: 30 | | | |

**Not Found, R304.5.1, R304.2.2**

| Compliance | Description | Data | Compliance | Description | Data |
|---|---|---|---|---|---|
| N/A | Ramp Length (in) | 49.0 | No | Ramp Slope (%) | 8.5 |
| No | Ramp Width (in) | 33.0 | Yes | Ramp XSlope (%) | 1.9 |

**Remove & Replace Entire Ramp.**

Total Cost: \$ 1850.00
