# Access Compliance Report

## Public Rights-of-Way

### (Curb Ramps)

Intersection ID: 42718	Main Street: PICKEREL_LN	Cross Street: PLANTAIN_CT	Location: W
ADA ID: 9AEEEDFCD879	Ramp Type: PerpDiag	Initial Pass/Fail: Fail	Overall Compliance: No
		Severity Score: 33.75

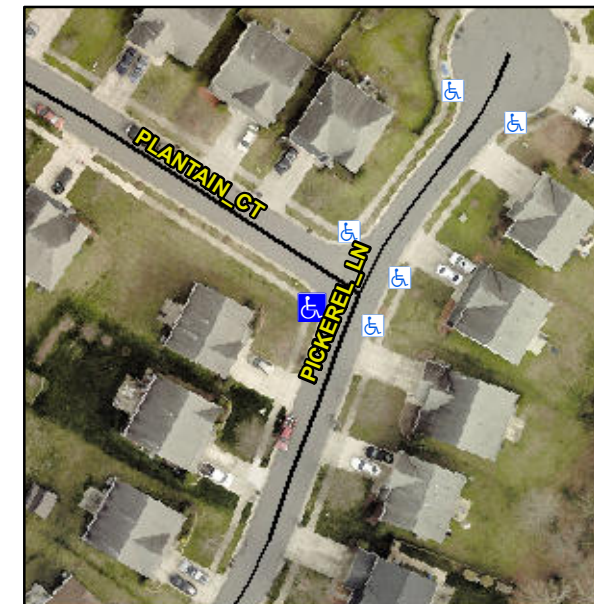
**Not Found, R304.5.1, R304.5.3**

Compliance	Description	Data	Compliance	Description	Data
N/A	Ramp Length (in)	46.0	Yes	Ramp Slope (%)	5.1
No	Ramp Width (in)	38.0	No	Ramp XSlope (%)	7.3
N/A	Flare Type LT	N/A	N/A	Flare Type RT	N/A
N/A	Flare Slope LT (%)	N/A	N/A	Flare Slope RT (%)	N/A
N/A	Flare Traversable LT?	N/A	N/A	Flare Traversable RT?	N/A
N/A	Landing Length (in)	N/A	N/A	DWS Provided?	N/A
N/A	Landing Width (in)	N/A	N/A	DWS Contrast?	N/A
N/A	Landing Slope (%)	N/A	N/A	DWS Length (in)	N/A
N/A	Landing X Slope (%)	N/A	N/A	DWS Full Width?	N/A
N/A	Landing Curb? (Y/N)	N/A	N/A	DWS Offset (in)	N/A
N/A	Shared Landing?	N/A			
N/A	Gutter Ponding?	N/A	N/A	Gutter Slope (%)	N/A
N/A	Gutter Lip Ht (in)	N/A	N/A	Gutter X Slope (%)	N/A
N/A	Painted X Walk1?	No	N/A	Painted X Walk2?	No
	X Walk 1 Direction	To SE		X Walk 2 Direction	To NE
N/A	X Walk 1 Width (in)	N/A	N/A	X Walk 2 Width (in)	N/A
	X Walk 1 Slope (%)	4.8		X Walk 2 Slope (%)	6.1
	X Walk 1 X Slope (%)	6.0		X Walk 2 X Slope (%)	0.4

N/A	Ramp inside XWalk1?	N/A	N/A	Ramp inside XWalk2?	N/A
	Road Slope (%)	4.0	N/A	Clear Space?	N/A
	Road X Slope (%)	7.1	N/A	Clear Space to XWalk (in)	N/A
N/A	Any Obstructions?	N/A	N/A	Storm Grate/Utility Hazard?	N/A
	Obstruction Type			Storm Grate/Utility Type	
		N/A			N/A
			Yes	Surface Condition? (G/P)	Good

**Remove & Replace Curb Ramp With Two New Directional Ramps or Equivalent.**
