Access Compliance Report

Public Rights-of-Way

(Curb Ramps)

Intersection ID: 10579	Main Street: RUSH_AV	Cross Street: TUCKASEEGEE_RD	Location: SW
ADA ID: 9AEF19FF112A	Ramp Type: Directional1	Initial Pass/Fail: Fail	Overall Compliance: No
Severity Score: 33.75			
Codes/Mitigation Info/Possible Solution		Field Measurements/Component Compliance

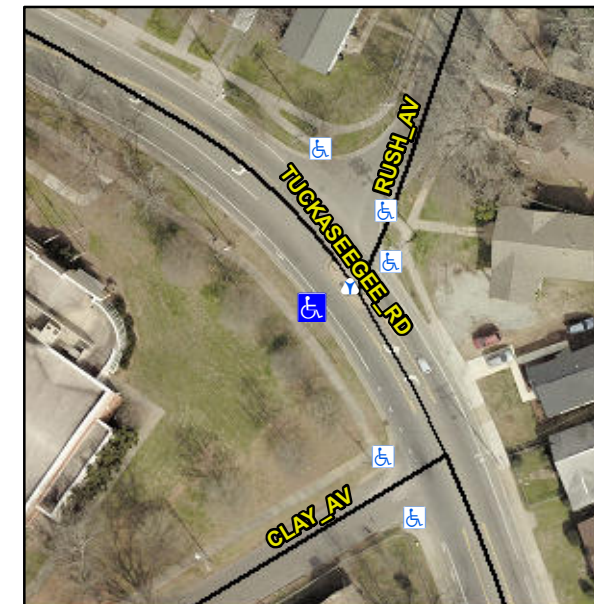
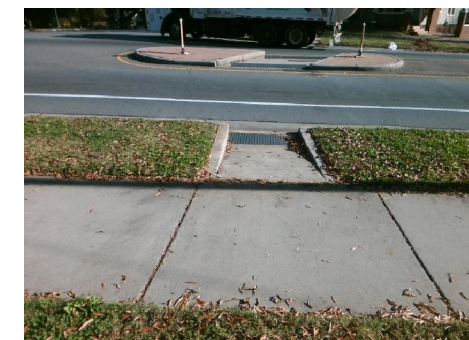
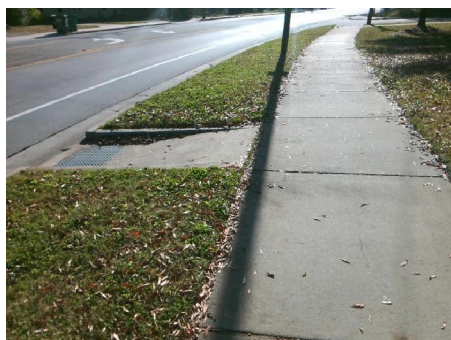
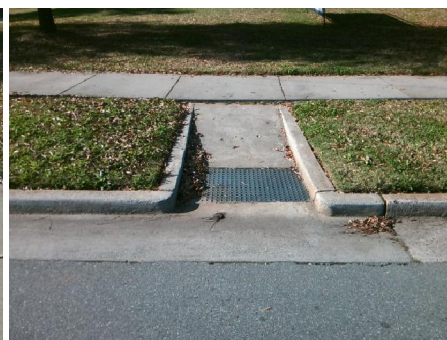
R304.5.1, R304.2.2

Compliance	Description	Data	Compliance	Description	Data
N/A	Ramp Length (in)	95.0	N/A	Grade Break?	N/A
No	Ramp Width (in)	45.0	N/A	Grade Break Slope (%)	0.0
No	Ramp Slope (%)	14.0	N/A	Grade Break XSlope (%)	0.0
Yes	Ramp XSlope (%)	0.9			
N/A	Flare Type LT	N/A	N/A	Flare Type RT	N/A
N/A	Flare Slope LT (%)	N/A	N/A	Flare Slope RT (%)	0.0
N/A	Flare Traversable LT?	N/A	N/A	Flare Traversable RT?	N/A
N/A	Landing Length (in)	0.0	N/A	DWS Provided?	N/A
N/A	Landing Width (in)	0.0	N/A	DWS Contrast?	N/A
N/A	Landing Slope (%)	0.0	N/A	DWS Length (in)	N/A
N/A	Landing X Slope (%)	0.0	N/A	DWS Full Width?	N/A
N/A	Landing Curb? (Y/N)	N/A	N/A	DWS Offset LT (in)	N/A
N/A	Shared Landing?	N/A	N/A	DWS Offset RT (in)	N/A
N/A	Gutter Ponding?	0.0	N/A	Gutter Slope (%)	N/A
N/A	Gutter Lip Ht (in)	0.0	N/A	Gutter X Slope (%)	N/A
N/A	Painted X Walk1?	No		Road Slope (%)	7.4
	X Walk 1 Direction	To NE		Road X Slope (%)	1.4
	X Walk 1 Width (in)	N/A		Clear Space?	N/A

X Walk 1 Slope (%)	7.4	N/A	Clear Space to XWalk (in)	N/A
	X Walk 1 X Slope (%)	1.4	N/A	Storm Grate/Utility Hazard?	N/A
N/A	Ramp inside XWalk1?	N/A		Storm Grate/Utility Type	
N/A	Any Obstructions?	N/A			N/A
	Obstruction Type		Yes	Surface Condition? (G/P)	Good
			N/A	Curb Slope (%)	12.8

Possible Solutions:

Remove & Replace Entire Ramp.
