# Access Compliance Report

## Public Rights-of-Way

| Intersection ID: N/A | Main Street: ALLISON_FOREST_TR | Cross Street: RUTAN_LN | Location: W |
| ADA ID: 9AF09A6B0EF2 | Ramp Type: BlendTrans1 | Initial Pass/Fail: Pass | Overall Compliance: No |

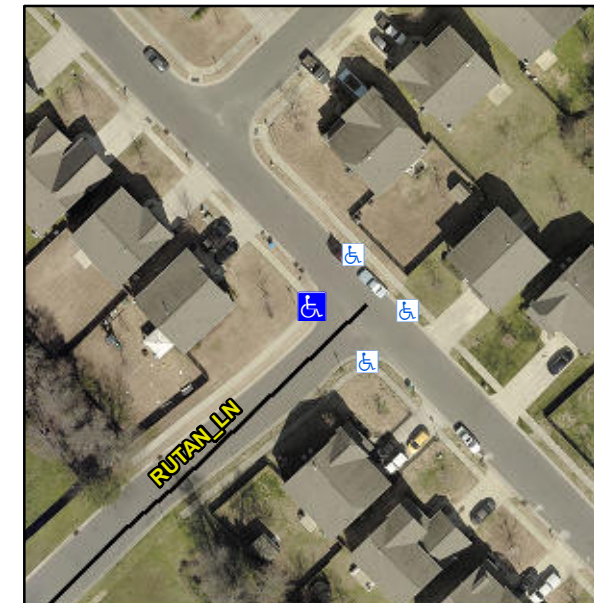
**Not Found, R304.5.3, R304.2.1, R304.2.2-Perp, R304.3.2-Para, R305.2**

| Compliance | Description | Data | Compliance | Description | Data |
|---|---|---|---|---|---|
| Yes | Ramp Width (in) | 48.0 | No | BlendTrans XSlope (%) | 2.6 |
| No | Landing Width (in) | 47.5 | Yes | DWS Contrast? | Yes |
| No | Landing Slope (%) | 2.6 | Yes | DWS Length (in) | 24.8 |
| No | Landing X Slope (%) | 4.7 | Yes | DWS Full Width? | Yes |
| N/A | Landing Curb? (Y/N) | No | No | DWS Offset (in) | 6.5 |
| Yes | Gutter Lip Ht (in) | 0.0 | No | Gutter X Slope (%) | 3.3 |

**Remove & Replace Curb Ramp With Two New Directional Ramps or Equivalent. Remove & Replace Gutter.**

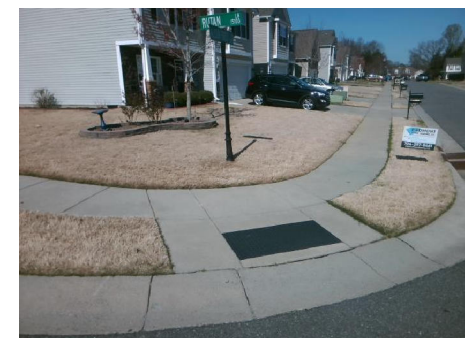
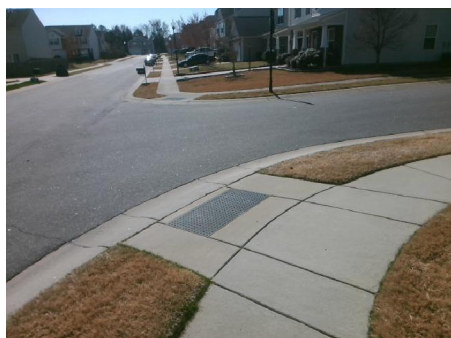
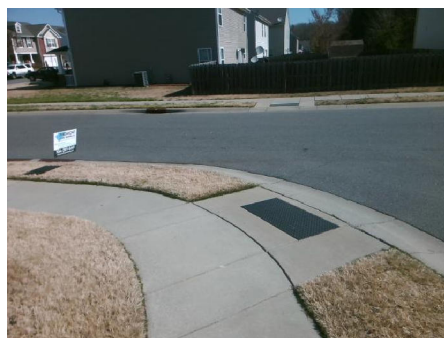
| | | | Severity Score: 0.25 |
