## Access Compliance Report Public Rights-of-Way (Curb Ramps)

Intersection ID: 13595 Main Street: DEWBERRY\_TR Cross Street: DR\_CARVER\_RD Location: SW

ADA ID: 9AFBA4EA2D5D Ramp Type: Para Initial Pass/Fail: Fail Overall Compliance: No Severity Score: 8.75

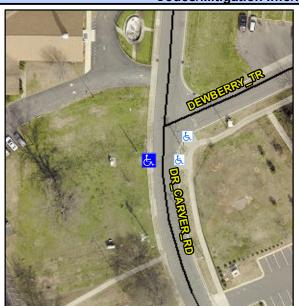
LT RP < 5%

Comp	liance Description	Data		nent Compliance	Data
	N/A	Ramp Length LT (in)	73.0	N/A	Ramp Length RT (in)	72.0
	No	Ramp Width LT (in)	46.0	No	Ramp Width RT (in)	46.0
	Yes	Ramp Slope LT (%)	1.4	Yes	Ramp Slope RT (%)	7.4
	Yes	Ramp XSlope LT (%)	1.6	Yes	Ramp XSlope RT (%)	0.3
	N/A	Landing Length (in)	N/A	N/A	DWS Provided?	N/A
	N/A	Landing Width (in)	N/A	N/A	DWS Contrast?	N/A
	N/A	Landing Slope (%)	N/A	N/A	DWS Length (in)	N/A
	N/A	Landing X Slope (%)	N/A	N/A	DWS Full Width?	N/A
	N/A	Landing Curb? (Y/N)	N/A	N/A	DWS Offset (in)	N/A
	N/A	Shared Landing?	N/A		, ,	
	N/A	Gutter Ponding?	N/A	N/A	Gutter Slope (%)	N/A
	N/A	Gutter Lip Ht (in)	N/A	N/A	Gutter X Slope (%)	N/A
	N/A	Painted X Walk1?	No	N/A	Painted X Walk2?	N/A
		X Walk 1 Direction	To E		X Walk 2 Direction	N/A
	N/A	X Walk 1 Width (in)	N/A	N/A	X Walk 2 Width (in)	N/A
		X Walk 1 Slope (%)	3.3		X Walk 2 Slope (%)	N/A
		X Walk 1 X Slope (%)	2.6		X Walk 2 X Slope (%)	N/A

N/A	Ramp inside XWalk1?	N/A	N/A	Ramp inside XWalk2?	N/A
		Road Slope (%)	N/A	N/A	Clear Space?	N/A
		Road X Slope (%)	N/A	N/A	Clear Space to XWalk (in)	N/A
	N/A	Any Obstructions?	N/A	N/A	Storm Grate/Utility Hazard?	N/A
		Obstruction Type			Storm Grate/Utility Type	
			N/A			N/A
				Yes	Surface Condition? (G/P)	Good
				N/A	Curb Slope (%)	22.1
4			·	-

Remove & Replace Entire Ramp.

R304.5.1

Total Cost: \$ 1600.00
