Access Compliance Report

Public Rights-of-Way

(Curb Ramps)

Intersection ID: 42646	Main Street: E_4TH_ST	Cross Street: S_TORRENCE_ST	Location: NW
ADA ID: 9AFDAD4ED382	Ramp Type: PerpDiag	Initial Pass/Fail: Fail	Overall Compliance: No
Severity Score: 12.5			
Codes/Mitigation Info/Possible Solution		Field Measurements/Component Compliance

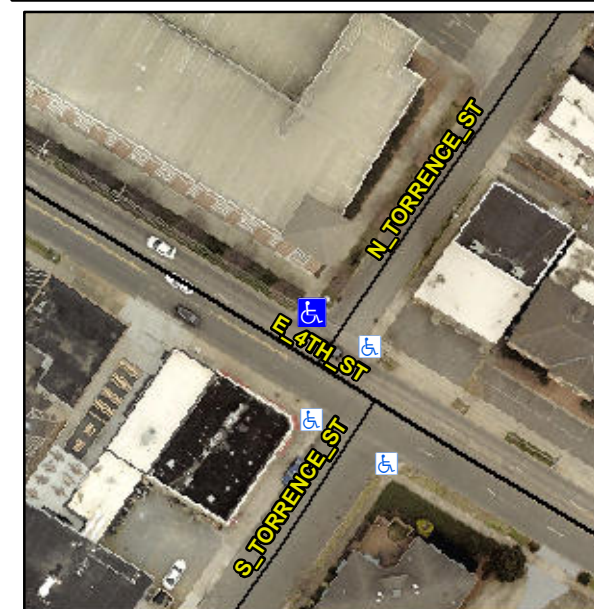
Compliance	Description	Data	Compliance	Description	Data
N/A	Ramp Length (in)	96.0	Yes	Ramp Slope (%)	5.2
Yes	Ramp Width (in)	50.0	No	Ramp XSlope (%)	6.8
N/A	Flare Type LT	N/A	N/A	Flare Type RT	N/A
N/A	Flare Slope LT (%)	N/A	N/A	Flare Slope RT (%)	N/A
N/A	Flare Traversable LT?	N/A	N/A	Flare Traversable RT?	N/A
N/A	Landing Length (in)	N/A	N/A	DWS Provided?	N/A
N/A	Landing Width (in)	N/A	N/A	DWS Contrast?	N/A
N/A	Landing Slope (%)	N/A	N/A	DWS Length (in)	N/A
N/A	Landing X Slope (%)	N/A	N/A	DWS Full Width?	N/A
N/A	Landing Curb? (Y/N)	N/A	N/A	DWS Offset (in)	N/A
N/A	Shared Landing?	N/A			
N/A	Gutter Ponding?	N/A	N/A	Gutter Slope (%)	N/A
N/A	Gutter Lip Ht (in)	N/A	N/A	Gutter X Slope (%)	N/A
N/A	Painted X Walk1?	No	N/A	Painted X Walk2?	No
	X Walk 1 Direction	To SW		X Walk 2 Direction	To SE
N/A	X Walk 1 Width (in)	N/A	N/A	X Walk 2 Width (in)	N/A
	X Walk 1 Slope (%)	1.8		X Walk 2 Slope (%)	3.6
	X Walk 1 X Slope (%)	3.1		X Walk 2 X Slope (%)	0.1

N/A	Ramp inside XWalk1?	N/A	N/A	Ramp inside XWalk2?	N/A
	Road Slope (%)	2.6	N/A	Clear Space?	N/A
	Road X Slope (%)	2.3	N/A	Clear Space to XWalk (in)	N/A
N/A	Any Obstructions?	N/A	N/A	Storm Grate/Utility Hazard?	N/A
	Obstruction Type			Storm Grate/Utility Type	
		N/A			N/A
		Yes		Surface Condition? (G/P)	Good

Remove & Replace Curb Ramp With Two New Directional Ramps or Equivalent.

R304.5.3
