# Access Compliance Report

## Public Rights-of-Way

### (Curb Ramps)

Intersection ID: 10232	Main Street: LAKEDELL_DR	Cross Street: SHANNONHOUSE_DR	Location: SW
ADA ID: 9B092B1383FD	Ramp Type: BlendTrans1	Initial Pass/Fail: Fail	Overall Compliance: No
		Severity Score: 1.25

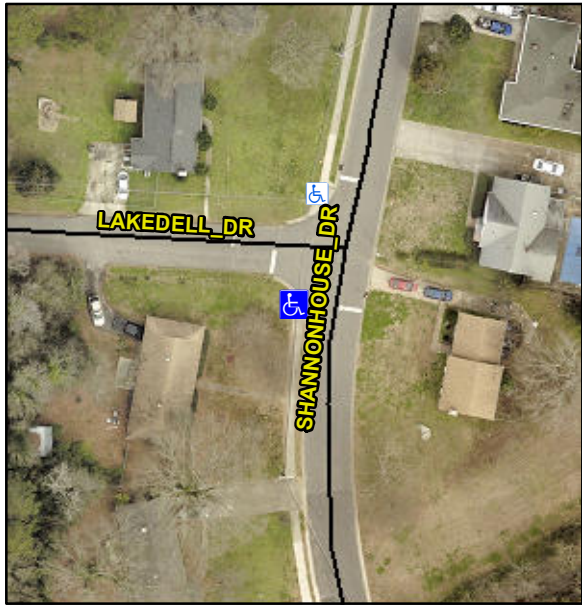
Possible Solutions:		Compliance	Description	Data	Compliance	Description	Data	
	Remove & Replace Curb Ramp With Two New Directional Ramps or Equivalent.		N/A	Ramp Length (in)	58.0	Yes	BlendTrans Slope (%)	3.4	
			Yes	Ramp Width (in)	60.0	No	BlendTrans XSlope (%)	2.1	
			N/A	Flare Type LT	N/A	N/A	Flare Type RT	N/A	
			N/A	Flare Slope LT (%)	N/A	N/A	Flare Slope RT (%)	N/A	
			N/A	Flare Traversable LT?	N/A	N/A	Flare Traversable RT?	N/A	
			N/A	Landing Length (in)	N/A	N/A	DWS Provided?	N/A	
			N/A	Landing Width (in)	N/A	N/A	DWS Contrast?	N/A	
			N/A	Landing Slope (%)	N/A	N/A	DWS Length (in)	N/A	
			N/A	Landing X Slope (%)	N/A	N/A	DWS Full Width?	N/A	
Surveyor Notes:  N/A			N/A	Landing Curb? (Y/N)	N/A	N/A	DWS Offset (in)	N/A	
			N/A	Shared Landing?	N/A				
			N/A	Gutter Ponding?	N/A	N/A	Gutter Slope (%)	N/A	
			N/A	Gutter Lip Ht (in)	N/A	N/A	Gutter X Slope (%)	N/A

N/A	Painted X Walk1?	No	N/A	Painted X Walk2?	N/A	
				X Walk 1 Direction	To N		X Walk 2 Direction	N/A	
				X Walk 1 Width (in)	N/A		X Walk 2 Width (in)	N/A	
				X Walk 1 Slope (%)	4.6		X Walk 2 Slope (%)	N/A	
				X Walk 1 X Slope (%)	1.5		X Walk 2 X Slope (%)	N/A	
			N/A	Ramp inside XWalk1?	N/A	N/A	Ramp inside XWalk2?	N/A	
PROW/ADA:  Not Found, R304.5.3				Road Slope (%)	1.5		Clear Space?	N/A	
				Road X Slope (%)	4.6	N/A	Clear Space to XWalk (in)	N/A	
			N/A	Any Obstructions?	N/A	N/A	Storm Grate/Utility Hazard?	N/A	
				Obstruction Type			Storm Grate/Utility Type		
						N/A		N/A	
						Yes	Surface Condition? (G/P)	Good	
						No	Curb Slope (%)	15.2	
	Total Cost:		\$	3200.00
