Access Compliance Report

Public Rights-of-Way

(Curb Ramps)

Intersection ID: N/A	Main Street: CHOATE_RD	Cross Street: N/A	Location: SW
ADA ID: 9B09EB9F6D88	Ramp Type: Directional1	Initial Pass/Fail: Fail	Overall Compliance: No
		Severity Score: 12.5

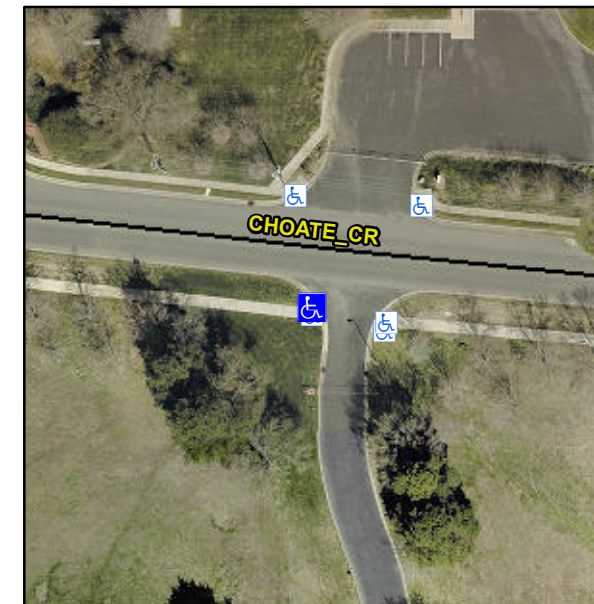
Compliance	Description	Data	Compliance	Description	Data
N/A	Ramp Length (in)	83.0	N/A	Grade Break?	N/A
Yes	Ramp Width (in)	74.0	N/A	Grade Break Slope (%)	0.0
No	Ramp Slope (%)	8.7	N/A	Grade Break XSlope (%)	0.0
Yes	Ramp XSlope (%)	0.4			
N/A	Flare Type LT	N/A	N/A	Flare Type RT	N/A
N/A	Flare Slope LT (%)	N/A	N/A	Flare Slope RT (%)	0.0
N/A	Flare Traversable LT?	N/A	N/A	Flare Traversable RT?	N/A
N/A	Landing Length (in)	0.0	N/A	DWS Provided?	N/A
N/A	Landing Width (in)	0.0	N/A	DWS Contrast?	N/A
N/A	Landing Slope (%)	0.0	N/A	DWS Length (in)	N/A
N/A	Landing X Slope (%)	0.0	N/A	DWS Full Width?	N/A
N/A	Landing Curb? (Y/N)	N/A	N/A	DWS Offset LT (in)	N/A
N/A	Shared Landing?	N/A	N/A	DWS Offset RT (in)	N/A
N/A	Gutter Ponding?	0.0	N/A	Gutter Slope (%)	N/A
N/A	Gutter Lip Ht (in)	0.0	N/A	Gutter X Slope (%)	N/A
N/A	Painted X Walk1?	No		Road Slope (%)	1.5
	X Walk 1 Direction	To E		Road X Slope (%)	0.3
	X Walk 1 Width (in)	N/A		Clear Space?	N/A

X Walk 1 Slope (%)	1.5	N/A	Clear Space to XWalk (in)	N/A
	X Walk 1 X Slope (%)	0.3	N/A	Storm Grate/Utility Hazard?	N/A
N/A	Ramp inside XWalk1?	N/A		Storm Grate/Utility Type	
N/A	Any Obstructions?	N/A			N/A
	Obstruction Type		Yes	Surface Condition? (G/P)	Good
			N/A	Curb Slope (%)	6.9

Possible Solutions:

Remove & Replace Entire Ramp.
