Access Compliance Report

Public Rights-of-Way

(Curb Ramps)

| Intersection ID: 52589 | Main Street: BURNETTE_AV | Cross Street: TRIUMPH_DR | Location: NE |

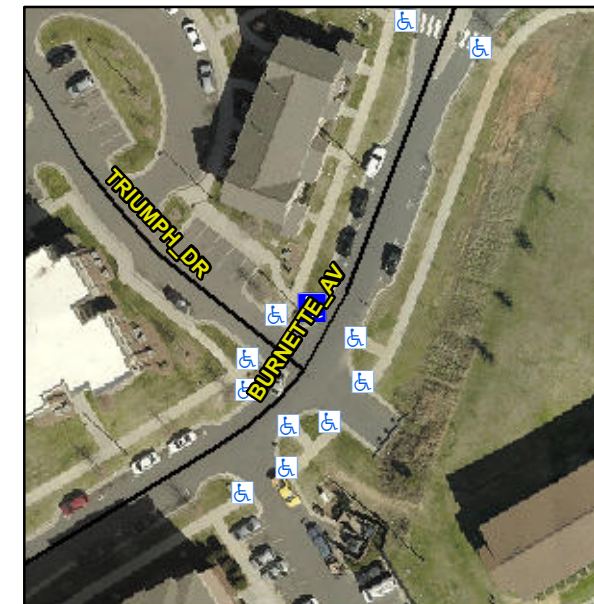
| ADA ID: 9B179FF05C63 | Ramp Type: Perp | Initial Pass/Fail: Fail | Overall Compliance: No |
| Severity Score: 12.5 | | | |

R304.2.2

| Compliance | Description | Data | Compliance | Description | Data |
|---|---|---|---|---|---|
| N/A | Ramp Length (in) | 72.0 | No | Ramp Slope (%) | 8.6 |

Remove & Replace Entire Ramp.
