Access Compliance Report Public Rights-of-Way (Curb Ramps)

Intersection ID: 12244 Main Street: BELMONT AV Cross Street: HARRILL_ST Location: N ADA ID: 9B1927336BBF Ramp Type: Directional1 Initial Pass/Fail: Pass **Overall Compliance: No Severity Score:** 5

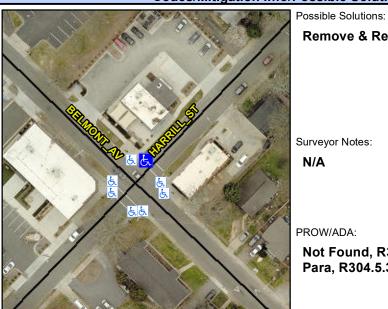
Field Measurements/Component Compliance					
Compli	ance Description	Data	Comp	oliance Description	Data
N/A	Ramp Length (in)	69.5	Yes	Grade Break?	Yes
Yes	Ramp Width (in)	58.5	Yes	Grade Break Slope (%)	3.2
Yes	Ramp Slope (%)	3.0	Yes	Grade Break XSlope (%)	0.2
Yes	Ramp XSlope (%)	1.6			
No	Flare Type LT	N/A	Yes	Flare Type RT	N/A
N/A	Flare Slope LT (%)	N/A	N/A	Flare Slope RT (%)	N/A
N/A	Flare Traversable LT?	No	N/A	Flare Traversable RT?	No
Yes	Landing Length (in)	60.0	Yes	DWS Provided?	Yes
Yes	Landing Width (in)	106.0	Yes	DWS Contrast?	Yes
No	Landing Slope (%)	2.9	Yes	DWS Length (in)	24.0
No	Landing X Slope (%)	3.4	Yes	DWS Full Width?	Yes
N/A	Landing Curb? (Y/N)	No	Yes	DWS Offset LT (in)	1.0
N/A	Shared Landing?	Yes	Yes	DWS Offset RT (in)	23.0
Yes	Gutter Ponding?	No	Yes	Gutter Slope (%)	4.9
Yes	Gutter Lip Ht (in)	0.0	Yes	Gutter X Slope (%)	1.4
N/A	Painted X Walk1?	Yes		Road Slope (%)	6.2
	X Walk 1 Direction	To SE		Road X Slope (%)	2.6

X Walk 1 Width (in)	96.0		Clear Space?	Yes
	X Walk 1 Slope (%)	6.2	N/A	Clear Space to XWalk (in)	N/A
	X Walk 1 X Slope (%)	2.6	Yes	Storm Grate/Utility Hazard?	No
Yes	Ramp inside XWalk1?	Yes		Storm Grate/Utility Type	
Yes	Any Obstructions?	No			N/A
	Obstruction Type		Yes	Surface Condition? (G/P)	Good
		N/A	No	Curb Slope (%)	9.1

Remove & Replace Entire Ramp. Surveyor Notes: N/A PROW/ADA: Not Found, R304.2.2-Perp, R304.3.2-Para, R304.5.3, R304.2.3
