Access Compliance Report

Public Rights-of-Way

(Curb Ramps)

Intersection ID: 28144	Main Street: DONNINGTON_DR	Cross Street: FULLER_PL	Location: E
ADA ID: 9B197517844F	Ramp Type: BlendTrans2	Initial Pass/Fail: Fail	Overall Compliance: No
		Severity Score: 12.5

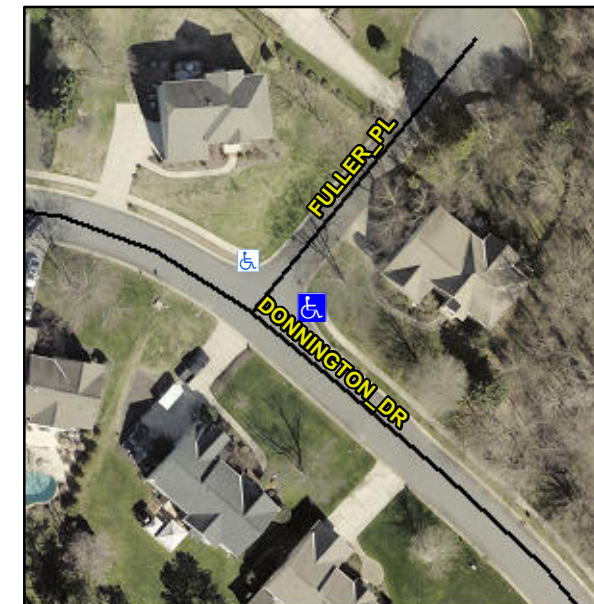
Compliance	Description	Data	Compliance	Description	Data
N/A	Ramp Length (in)	95.0	Yes	BlendTrans Slope (%)	3.4
Yes	Ramp Width (in)	93.0	No	BlendTrans XSlope (%)	5.7
N/A	Flare Type LT	N/A	N/A	Flare Type RT	N/A
N/A	Flare Slope LT (%)	N/A	N/A	Flare Slope RT (%)	N/A
N/A	Flare Traversable LT?	N/A	N/A	Flare Traversable RT?	N/A
N/A	Landing Length (in)	N/A	N/A	DWS Provided?	N/A
N/A	Landing Width (in)	N/A	N/A	DWS Contrast?	N/A
N/A	Landing Slope (%)	N/A	N/A	DWS Length (in)	N/A
N/A	Landing X Slope (%)	N/A	N/A	DWS Full Width?	N/A
N/A	Landing Curb? (Y/N)	N/A	N/A	DWS Offset (in)	N/A
N/A	Shared Landing?	N/A			
N/A	Gutter Ponding?	N/A	N/A	Gutter Slope (%)	N/A
N/A	Gutter Lip Ht (in)	N/A	N/A	Gutter X Slope (%)	N/A
N/A	Painted X Walk1?	No	N/A	Painted X Walk2?	No
	X Walk 1 Direction	To NW		X Walk 2 Direction	To SW
	X Walk 1 Width (in)	N/A		X Walk 2 Width (in)	N/A
	X Walk 1 Slope (%)	6.9		X Walk 2 Slope (%)	3.8
	X Walk 1 X Slope (%)	4.9		X Walk 2 X Slope (%)	5.8

N/A	Ramp inside XWalk1?	N/A	N/A	Ramp inside XWalk2?	N/A
	Road Slope (%)	3.5		Clear Space?	N/A
	Road X Slope (%)	7.6	N/A	Clear Space to XWalk (in)	N/A
N/A	Any Obstructions?	N/A	N/A	Storm Grate/Utility Hazard?	N/A
	Obstruction Type			Storm Grate/Utility Type	
		N/A			N/A
			Yes	Surface Condition? (G/P)	Good
			N/A	Curb Slope (%)	1.1

Remove & Replace Curb Ramp With Two New Directional Ramps or Equivalent.

R304.5.3
