# Access Compliance Report

## Public Rights-of-Way

### (Curb Ramps)

Intersection ID: 10039270	Main Street: SUNSET_RD	Cross Street: N/A	Location: S
ADA ID: 9B2217A58410	Ramp Type: Para	Initial Pass/Fail: Pass	Overall Compliance: No
			Severity Score: 5

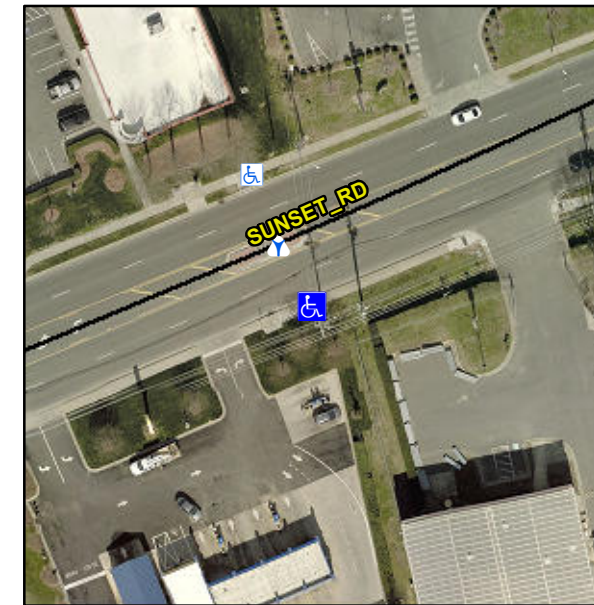
**Not Found, R304.5.4**

Compliance	Description	Data	Compliance	Description	Data
N/A	Ramp Length LT (in)	78.0	N/A	Ramp Length RT (in)	76.0
Yes	Ramp Width LT (in)	60.0	Yes	Ramp Width RT (in)	60.0
Yes	Ramp Slope LT (%)	7.6	Yes	Ramp Slope RT (%)	7.7
Yes	Ramp XSlope LT (%)	0.9	Yes	Ramp XSlope RT (%)	0.9
Yes	Landing Length (in)	60.0	Yes	DWS Provided?	Yes
Yes	Landing Width (in)	48.0	Yes	DWS Contrast?	Yes
Yes	Landing Slope (%)	0.9	Yes	DWS Length (in)	24.0
Yes	Landing X Slope (%)	0.2	Yes	DWS Full Width?	Yes
N/A	Landing Curb? (Y/N)	Yes	Yes	DWS Offset (in)	0.0
N/A	Shared Landing?	No			
Yes	Gutter Ponding?	No	No	Gutter Slope (%)	8.8
Yes	Gutter Lip Ht (in)	0.0	Yes	Gutter X Slope (%)	1.5
N/A	Painted X Walk1?	No	N/A	Painted X Walk2?	N/A
	X Walk 1 Direction	To NW		X Walk 2 Direction	N/A
N/A	X Walk 1 Width (in)	N/A	N/A	X Walk 2 Width (in)	N/A
	X Walk 1 Slope (%)	2.0		X Walk 2 Slope (%)	N/A
	X Walk 1 X Slope (%)	1.4		X Walk 2 X Slope (%)	N/A
N/A	Ramp inside XWalk1?	N/A	N/A	Ramp inside XWalk2?	N/A

Road Slope (%)	N/A	N/A	Clear Space?	Yes
	Road X Slope (%)	N/A	N/A	Clear Space to XWalk (in)	N/A
Yes	Any Obstructions?	No	Yes	Storm Grate/Utility Hazard?	No
	Obstruction Type			Storm Grate/Utility Type	
			N/A		N/A
			Yes	Surface Condition? (G/P)	Good
				Replace Curb Slope (%)	9.1

**Remove & Replace Entire Ramp.  
Remove & Replace Gutter.**
