# Access Compliance Report

## Public Rights-of-Way

### (Curb Ramps)

| Intersection ID: 7397 | Main Street: JEFF_ADAMS_DR | Cross Street: N_GRAHAM_ST | Location: S |

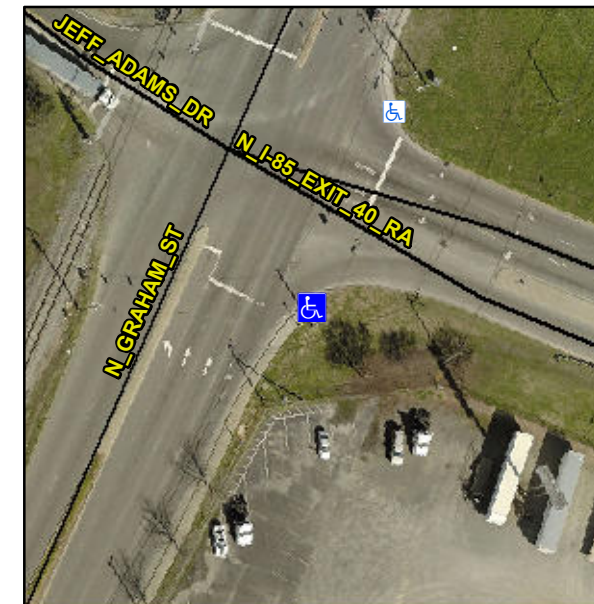
**Not Found, R304.5.1, R304.2.2, R304.5.3**

| Compliance | Description | Data | Compliance | Description | Data |
|---|---|---|---|---|---|
| N/A | Ramp Length (in) | 61.0 | No | Ramp Slope (%) | 12.9 |
| No | Ramp Width (in) | 47.5 | No | Ramp XSlope (%) | 2.1 |

**Remove & Replace Entire Ramp.**
