Access Compliance Report

Public Rights-of-Way

(Curb Ramps)

Intersection ID: 53390	Main Street: KELBURN_LN	Cross Street: AGNEW_DR	Location: SW
ADA ID: 9B2717781942	Ramp Type: Perp	Initial Pass/Fail: Fail	Overall Compliance: No
Codes/Mitigation Info/Possible Solution			Severity Score: 10
Field Measurements/Component Compliance

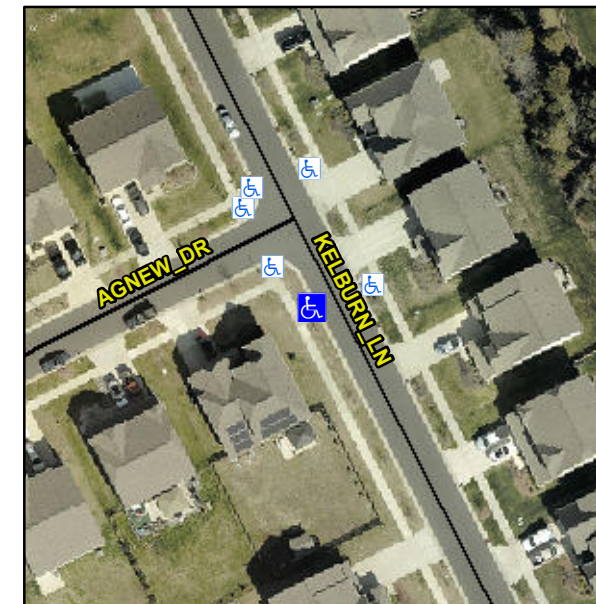
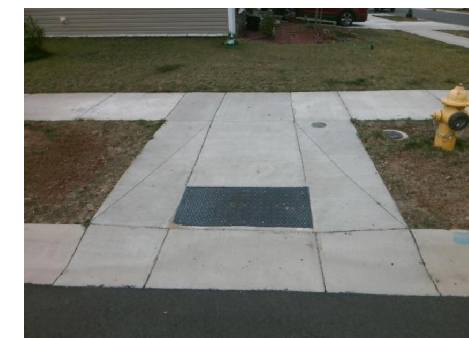
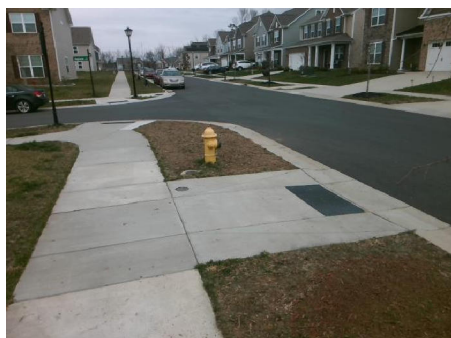
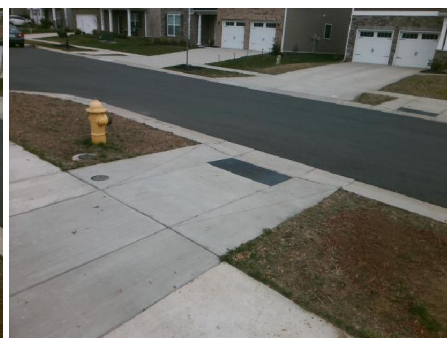
R304.5.1, R304.5.3

Compliance	Description	Data	Compliance	Description	Data
N/A	Ramp Length (in)	95.0	Yes	Ramp Slope (%)	5.1
No	Ramp Width (in)	45.0	No	Ramp XSlope (%)	2.2
N/A	Flare Type LT	N/A	N/A	Flare Type RT	N/A
N/A	Flare Slope LT (%)	N/A	N/A	Flare Slope RT (%)	N/A
N/A	Flare Traversable LT?	N/A	N/A	Flare Traversable RT?	N/A
N/A	Landing Length (in)	N/A	N/A	DWS Provided?	N/A
N/A	Landing Width (in)	N/A	N/A	DWS Contrast?	N/A
N/A	Landing Slope (%)	N/A	N/A	DWS Length (in)	N/A
N/A	Landing X Slope (%)	N/A	N/A	DWS Full Width?	N/A
N/A	Landing Curb? (Y/N)	N/A	N/A	DWS Offset (in)	N/A
N/A	Shared Landing?	N/A			
N/A	Gutter Ponding?	N/A	N/A	Gutter Slope (%)	N/A
N/A	Gutter Lip Ht (in)	N/A	N/A	Gutter X Slope (%)	N/A
N/A	Painted X Walk1?	No	N/A	Painted X Walk2?	N/A
	X Walk 1 Direction	To NE		X Walk 2 Direction	N/A
N/A	X Walk 1 Width (in)	N/A	N/A	X Walk 2 Width (in)	N/A
	X Walk 1 Slope (%)	3.1		X Walk 2 Slope (%)	N/A
	X Walk 1 X Slope (%)	1.3		X Walk 2 X Slope (%)	N/A

N/A	Ramp inside XWalk1?	N/A	N/A	Ramp inside XWalk2?	N/A
	Road Slope (%)	N/A	N/A	Clear Space?	N/A
	Road X Slope (%)	N/A	N/A	Clear Space to XWalk (in)	N/A
N/A	Any Obstructions?	N/A	N/A	Storm Grate/Utility Hazard?	N/A
	Obstruction Type			Storm Grate/Utility Type	
		N/A			N/A
			Yes	Surface Condition? (G/P)	Good

Remove & Replace Entire Ramp.

\$ 1850.00
