Access Compliance Report

Public Rights-of-Way

(Curb Ramps)

Intersection ID: 6933	Main Street: OAKDALE_RD	Cross Street: OLD_PLANK_RD	Location: NE
ADA ID: 9B396EEAFD78	Ramp Type: Directional1	Initial Pass/Fail: Fail	Overall Compliance: No
		Severity Score: 12.5

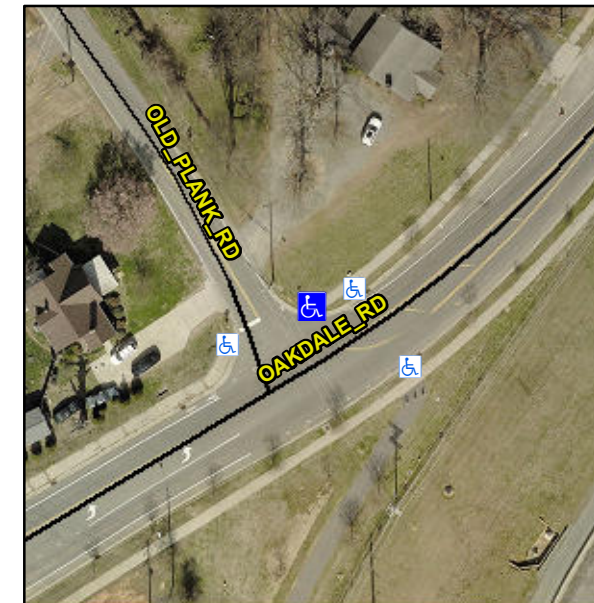
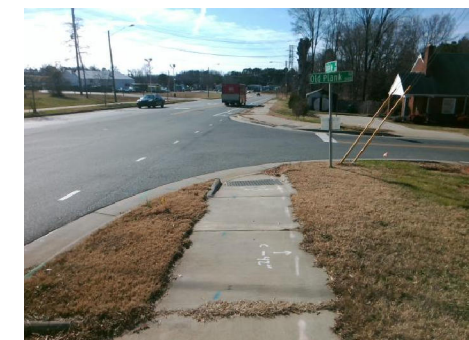
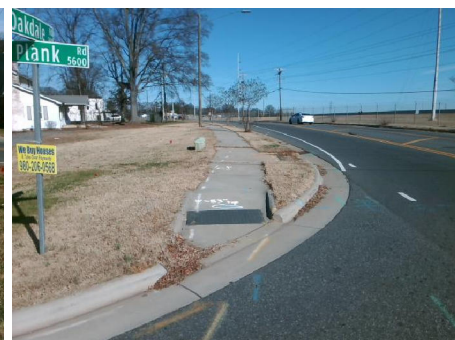
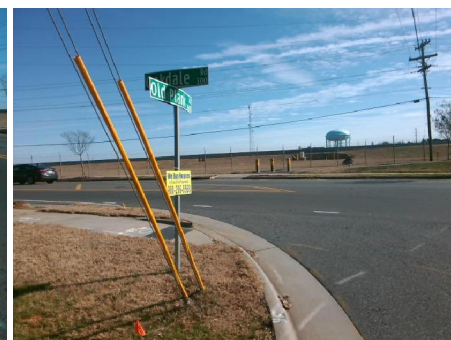
R304.2.2

Compliance	Description	Data	Compliance	Description	Data
N/A	Ramp Length (in)	131.0	N/A	Grade Break?	N/A
Yes	Ramp Width (in)	52.0	N/A	Grade Break Slope (%)	0.0
No	Ramp Slope (%)	9.6	N/A	Grade Break XSlope (%)	0.0
Yes	Ramp XSlope (%)	1.9			
N/A	Flare Type LT	N/A	N/A	Flare Type RT	N/A
N/A	Flare Slope LT (%)	N/A	N/A	Flare Slope RT (%)	0.0
N/A	Flare Traversable LT?	N/A	N/A	Flare Traversable RT?	N/A
N/A	Landing Length (in)	0.0	N/A	DWS Provided?	N/A
N/A	Landing Width (in)	0.0	N/A	DWS Contrast?	N/A
N/A	Landing Slope (%)	0.0	N/A	DWS Length (in)	N/A
N/A	Landing X Slope (%)	0.0	N/A	DWS Full Width?	N/A
N/A	Landing Curb? (Y/N)	N/A	N/A	DWS Offset LT (in)	N/A
N/A	Shared Landing?	N/A	N/A	DWS Offset RT (in)	N/A
N/A	Gutter Ponding?	0.0	N/A	Gutter Slope (%)	N/A
N/A	Gutter Lip Ht (in)	0.0	N/A	Gutter X Slope (%)	N/A
N/A	Painted X Walk1?	No		Road Slope (%)	3.1
	X Walk 1 Direction	To SW		Road X Slope (%)	2.3
	X Walk 1 Width (in)	N/A		Clear Space?	N/A

X Walk 1 Slope (%)	3.1	N/A	Clear Space to XWalk (in)	N/A
	X Walk 1 X Slope (%)	2.3	N/A	Storm Grate/Utility Hazard?	N/A
N/A	Ramp inside XWalk1?	N/A		Storm Grate/Utility Type	
N/A	Any Obstructions?	N/A			N/A
	Obstruction Type		Yes	Surface Condition? (G/P)	Good
			N/A	Curb Slope (%)	8.9

Remove & Replace Entire Ramp.

Total Cost: \$ 1600.00
