Intersection ID: 3350	Main Street: FALLS_RIDGE_LN	Cross Street: CANIPE_DR	Location:	NE
ADA ID: 9B3A8CBF0C0E	Ramp Type: BlendTrans1	Initial Pass/Fail: Fail	Overall Compliance: No	Severity Score: 25

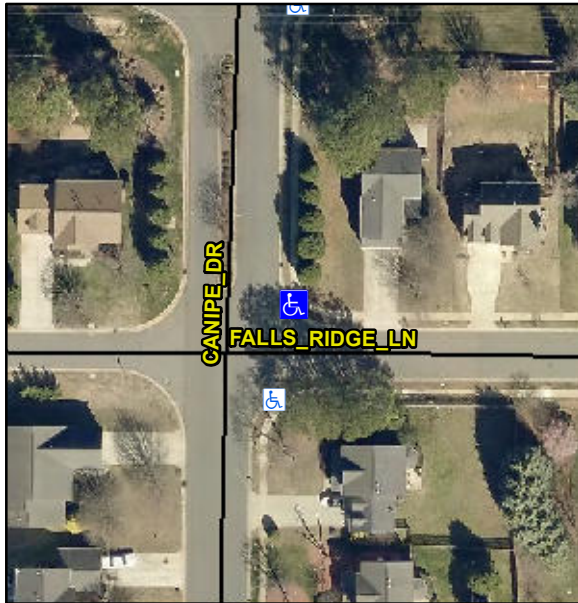
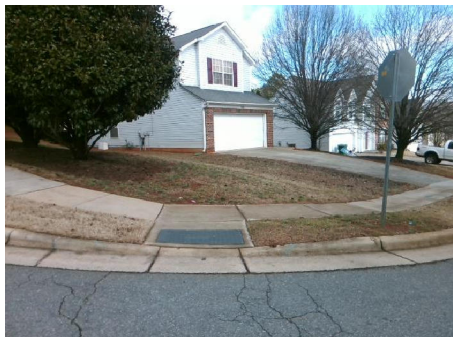
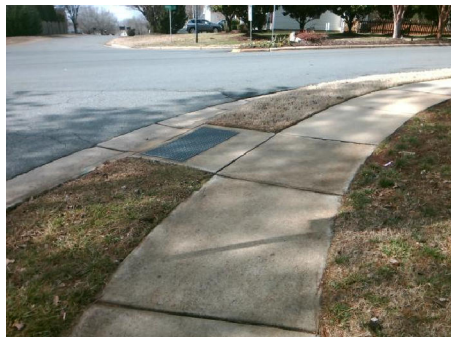
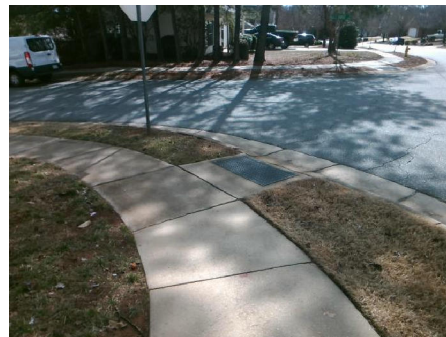
**Not Found, R304.5.3**

Compliance	Description	Data	Compliance	Description	Data
N/A	Ramp Length (in)	47.5	Yes	BlendTrans Slope (%)	3.2
Yes	Ramp Width (in)	60.0	No	BlendTrans XSlope (%)	7.6
N/A	Flare Type LT	N/A	N/A	Flare Type RT	N/A
N/A	Flare Slope LT (%)	N/A	N/A	Flare Slope RT (%)	N/A
N/A	Flare Traversable LT?	N/A	N/A	Flare Traversable RT?	N/A
N/A	Landing Length (in)	N/A	N/A	DWS Provided?	N/A
N/A	Landing Width (in)	N/A	N/A	DWS Contrast?	N/A
N/A	Landing Slope (%)	N/A	N/A	DWS Length (in)	N/A
N/A	Landing X Slope (%)	N/A	N/A	DWS Full Width?	N/A
N/A	Landing Curb? (Y/N)	N/A	N/A	DWS Offset (in)	N/A
N/A	Shared Landing?	N/A			
N/A	Gutter Ponding?	N/A	N/A	Gutter Slope (%)	N/A
N/A	Gutter Lip Ht (in)	N/A	N/A	Gutter X Slope (%)	N/A
N/A	Painted X Walk1?	No	N/A	Painted X Walk2?	N/A
	X Walk 1 Direction	To S		X Walk 2 Direction	N/A
	X Walk 1 Width (in)	N/A		X Walk 2 Width (in)	N/A
	X Walk 1 Slope (%)	2.8		X Walk 2 Slope (%)	N/A
	X Walk 1 X Slope (%)	7.8		X Walk 2 X Slope (%)	N/A

N/A	Ramp inside XWalk1?	N/A	N/A	Ramp inside XWalk2?	N/A
	Road Slope (%)	7.8		Clear Space?	N/A
	Road X Slope (%)	2.8	N/A	Clear Space to XWalk (in)	N/A
N/A	Any Obstructions?	N/A	N/A	Storm Grate/Utility Hazard?	N/A
	Obstruction Type			Storm Grate/Utility Type	
		N/A			N/A
			Yes	Surface Condition? (G/P)	Good
			No	Curb Slope (%)	11.4

**Remove & Replace Curb Ramp With Two New Directional Ramps or Equivalent.**
