Access Compliance Report

Public Rights-of-Way

(Curb Ramps)

Intersection ID: 8816	Main Street: BROOKSTEAD MEADOW CT	Cross Street: NORKETT DR	Location: W
ADA ID: 9B4231A5E7EF	Ramp Type: PerpDiag	Initial Pass/Fail: Fail	Overall Compliance: No
Severity Score: 8.75			
Codes/Mitigation Info/Possible Solution		Field Measurements/Component Compliance

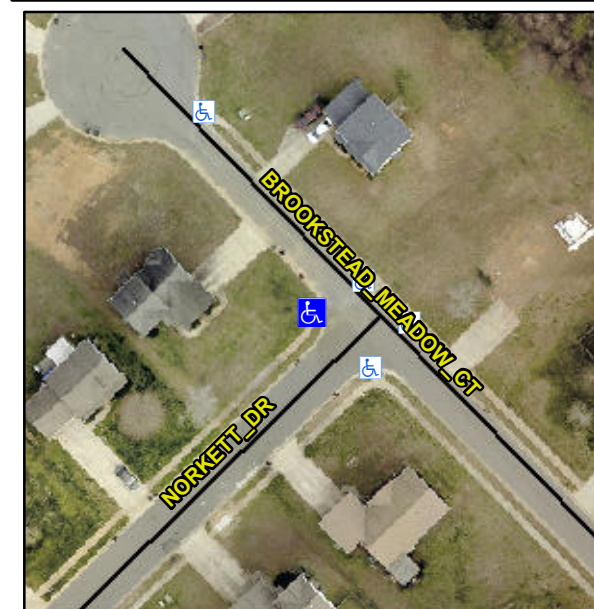
Not Found, R304.5.1

Compliance	Description	Data	Compliance	Description	Data
N/A	Ramp Length (in)	49.5	Yes	Ramp Slope (%)	7.0
No	Ramp Width (in)	41.0	Yes	Ramp XSlope (%)	0.0
N/A	Flare Type LT	N/A	N/A	Flare Type RT	N/A
N/A	Flare Slope LT (%)	N/A	N/A	Flare Slope RT (%)	N/A
N/A	Flare Traversable LT?	N/A	N/A	Flare Traversable RT?	N/A
N/A	Landing Length (in)	N/A	N/A	DWS Provided?	N/A
N/A	Landing Width (in)	N/A	N/A	DWS Contrast?	N/A
N/A	Landing Slope (%)	N/A	N/A	DWS Length (in)	N/A
N/A	Landing X Slope (%)	N/A	N/A	DWS Full Width?	N/A
N/A	Landing Curb? (Y/N)	N/A	N/A	DWS Offset (in)	N/A
N/A	Shared Landing?	N/A			
N/A	Gutter Ponding?	N/A	N/A	Gutter Slope (%)	N/A
N/A	Gutter Lip Ht (in)	N/A	N/A	Gutter X Slope (%)	N/A
N/A	Painted X Walk1?	No	N/A	Painted X Walk2?	No
	X Walk 1 Direction	To SE		X Walk 2 Direction	To NE
N/A	X Walk 1 Width (in)	N/A	N/A	X Walk 2 Width (in)	N/A
	X Walk 1 Slope (%)	2.6		X Walk 2 Slope (%)	1.3
	X Walk 1 X Slope (%)	0.2		X Walk 2 X Slope (%)	3.7

N/A	Ramp inside XWalk1?	N/A	N/A	Ramp inside XWalk2?	N/A
	Road Slope (%)	2.0	N/A	Clear Space?	N/A
	Road X Slope (%)	1.2	N/A	Clear Space to XWalk (in)	N/A
N/A	Any Obstructions?	N/A	N/A	Storm Grate/Utility Hazard?	N/A
	Obstruction Type			Storm Grate/Utility Type	
		N/A			N/A
			Yes	Surface Condition? (G/P)	Good

Remove & Replace Curb Ramp With Two New Directional Ramps or Equivalent.

Total Cost: \$ 3200.00
